## **THE VULNERABILITY OF SCARPS CAUSED BY ANTHROPIC IMPACT. CASE STUDY: THE BREAZA TERRACE SCARP - THE PRAHOVA VALLEY**

**Iuliana Armaş, Răsvan Damian, Florica Stroia**

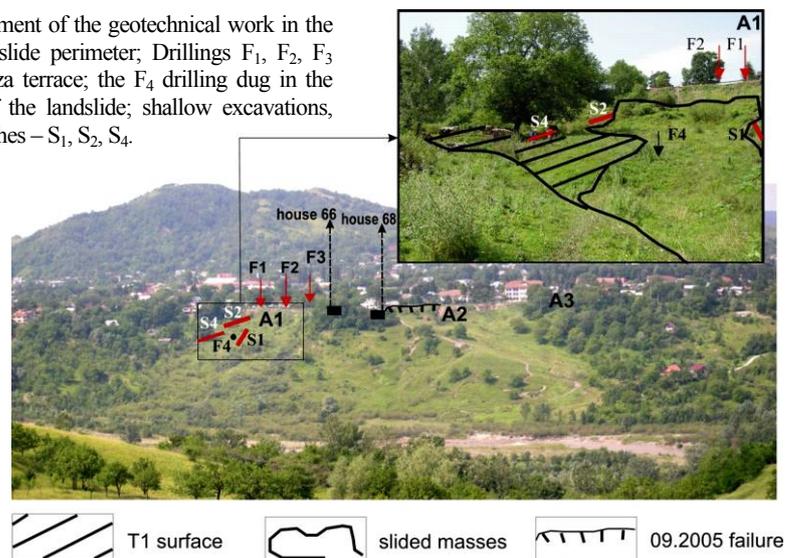
In the summer of 2006 there followed the measurement of the thickness of the masses that slid and the identification of the geotechnical parameters of the sliding bed. Four drillings of small depth were thus made manually in the gravel of the terrace and in the mass that slid and two uncoverings and one ditch were made in the mass that slid reaching to the "in situ" rock. (Fig.1).

Fig. 1 The placement of the geotechnical work in the M Căproiu landslide perimeter; Drillings F<sub>1</sub>, F<sub>2</sub>, F<sub>3</sub> dug in the Breaza terrace; the F<sub>4</sub> drilling dug in the central sector of the landslide; shallow excavations, trenches and ditches – S<sub>1</sub>, S<sub>2</sub>, S<sub>4</sub>.

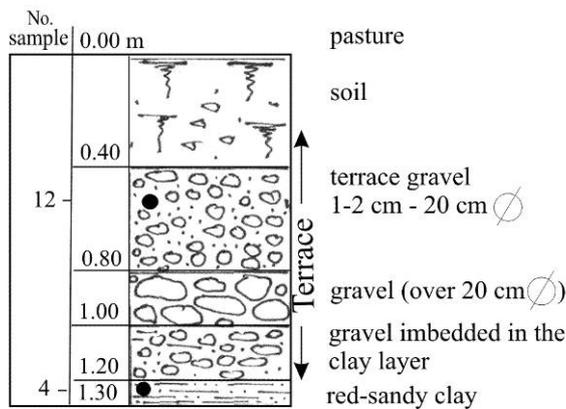
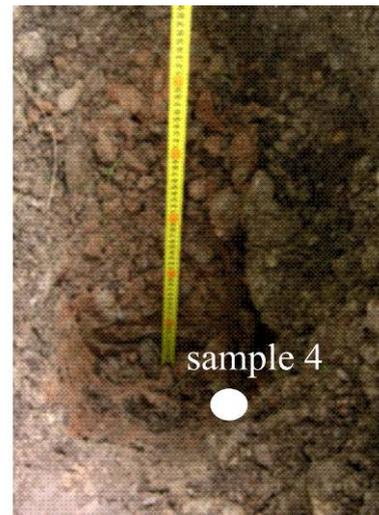
Fig. 2.a.

bearing mica, solidified. In a dry state, they have a consistency index of a *solid rock*. (Towards the edge of the landslide, the ditches dug showed slide masses of 1.5 to 2 m thick and the bed of the slide formed by red sands with centimetric pellicles of clay).

Fig. 2. The lithological characteristics shown in the geotechnical work: a) the S<sub>4</sub> ditch; b) the F<sub>4</sub> drilling, dug in the central sector of the landslide

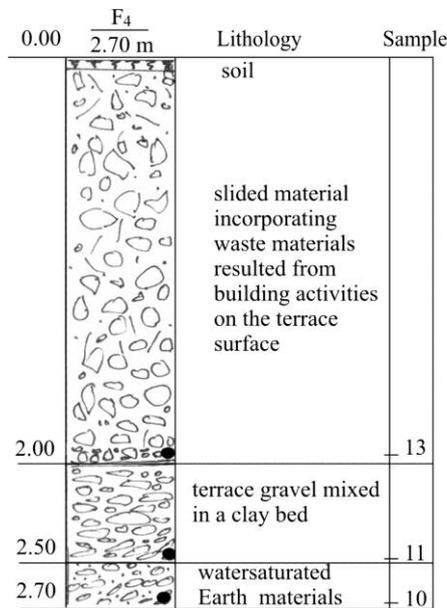
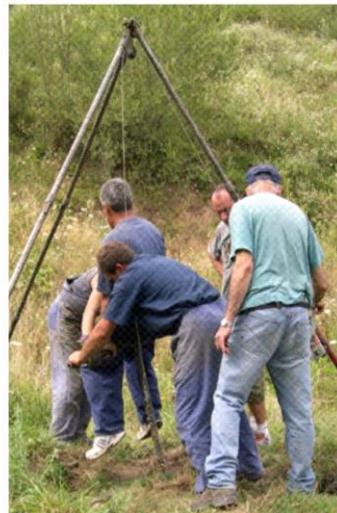
Fig.2.b.

The extension of the material in the terraces was estimated by interpreting some carbonatic tubercular material stored with a granular concentric structure, formed on the surface of the buckets through the circulation of the water in the gravels of the terrace. We noticed these aspects in the material of terrace II and on the gravels uncovered slide (opened and analyzed in S<sub>4</sub> ditch- see Fig. 2, a). This observation proves that even a short period of time in which the gravels were covered by the slide mass (characterized by an active water circulation) can determine the “wash of this ornamentation” (on the gravels taken from 2,40 m deep in the F<sub>4</sub> drilling, dug in the central sector of the landslide – see Fig. 2, b).

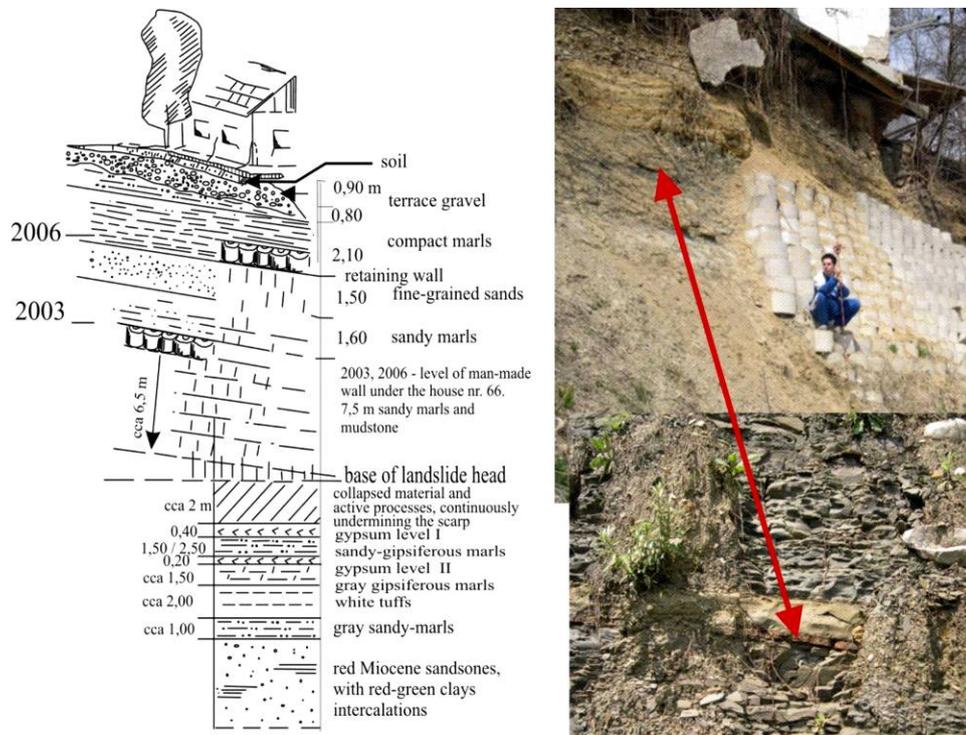
By mapping the Prahova scarp, in the section uncovered by the failure of the scarp under M. Căproiu house number 66, and from the lithological particularities emphasized by the landslide at the intersection between M. Căproiu Street and V. Alecsandri Street – the geological characteristics of the layers from this flank of the Breaza – Buciumeni syncline could be observed (Fig. 3).

Fig. 3. Outcrop formed under the number 66 house (A1 landslide)

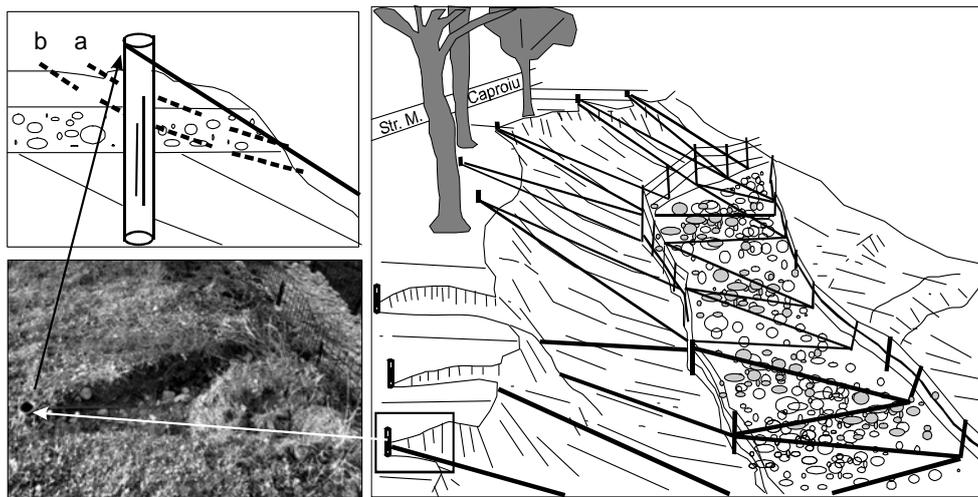
A heavy supporting parapet was built and about 20 mc of rock were placed in two steps, supported by metal poles placed vertically about 2 m deep. Metal nets were put among between the poles (Fig. 4).

Because of the rock mass slide appeared while executing the work, posts of a similar type were placed at the edge of the terrace, on which supporting straps were fused.

Fig. 4. Landslide A3, reactivated by the “supporting walls” and anchor straps. “a” and “b” are ditches deepening very fast by washing processes

1. The rocks brought (with heavy trucks!) which form the two “supporting walls” are obviously too heavy and were placed on an accentuated slope, without processing the base in order to become stable;

2. The anchor straps are inadequate to the static pressures (wire with the diameter of 0.8 cm, fused punctually on the pipes in question);
3. The pipes placed have very small diameters in relation with the tasks done (5 cm in diameter); they will be easy to bend and will be chemically corroded in a short period of time (they are already filled with water that contains ferruginous gel);
4. The scarp was prepared for this work by uncovering the vegetation and, on the path of the straps, by digging positioning ditches. These ditches, initially of low depth, from 10 to 30 cm, are deepening very fast (in Oct. 2006) by the washing of the soil and of the terrace material;
5. At the base of the whole “structure” water is being drained and in some sectors it is puddling.
