PESD, VOL. 11, no. 2, 2017

## ANALYSIS OF THE HYDROCLIMATIC RISK PARAMETERS AT THE HIGH LEVEL OF THE TAZLĂUL SĂRAT RIVER IN 2016 YEAR

Mihail Luca<sup>1</sup>, Mihaela Avram<sup>2</sup>

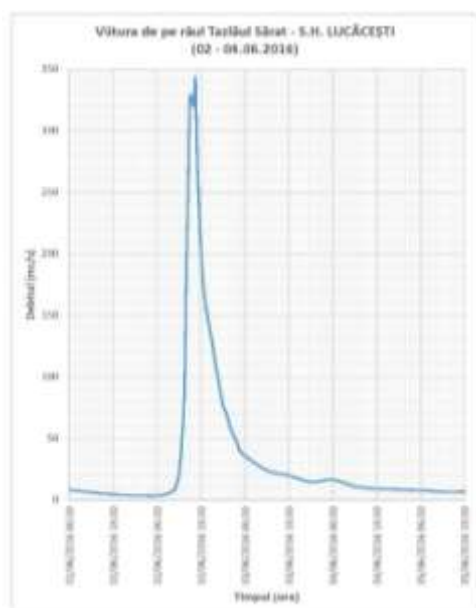
The flood wave formed in June 2016 on the Tazlăul Sărat River showed a flow rate of 342 m<sup>3</sup>/s, a value approaching the 3% probability (Table 3, Fig. 2).

The flood on the Tazlăul Sărat River started on 02.06.2016, at 10.00, with a 69 cm share and a flow of 6.70 m<sup>3</sup>/s. The peak of the flood was recorded on 02.06.2016, at 16.30, where the quota reached 360 cm and a maximum flow of 342m<sup>3</sup>/s. The 2.73 m flood gauge has overtaken the banks and has caused major

Fig. 2. The flood level hydrograph on the Tazlăul Sărat river, the Lucăcești H.S.

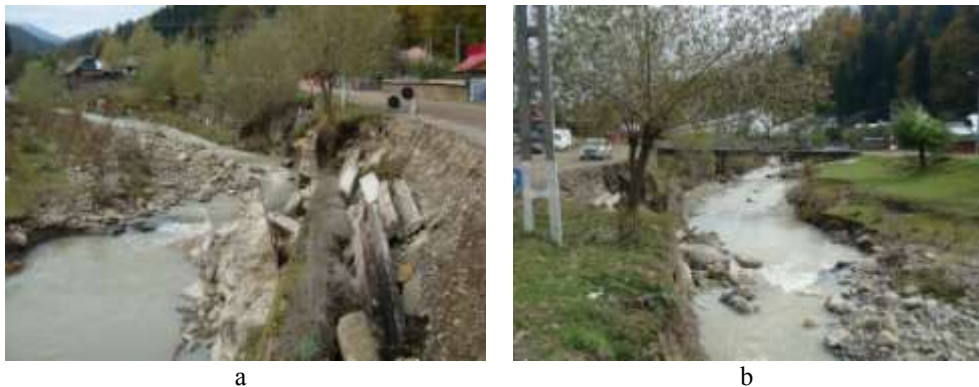
*Zone 1 - "Toderaş"*. The shore defence is executed from a simple concrete wall to the road elevation. The shore defence was degraded by 40-90% over a length of 60 m. The flood waves have morphologically modified the Tazlăul Salt Riverbed in the "Toderaş" curvature area, causing the bedding to be dampened and the tallo descended, which influenced the shore defence behaviour and the degradation over time. The defence of the wall of a support wall made of simple concrete, located on the left bank in the curvature area, was completely destroyed in the central section (Fig. 4). The river also acts on small water on the bank, resulting in the continuous degradation of the structural components of the defence and further on the foundation layer of the communal road.

Fig. 4. General view of the morphology of the Tazlăul Sărat riverbed and the state of degradation of shore defence and DC 180A in Zone 1 "Toderaş": a - general view from downstream with highlighting the erosion of the road; b - upstream view (Oct 2016)

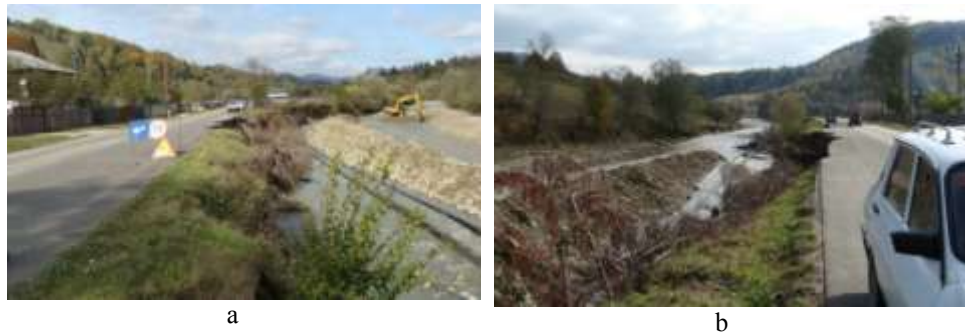
*Zone 3. "Chiosa"*. The Tazlăul Sărat River has a right curve in this area, after which it maintains a linear downstream (Fig. 5a). At the end of the curve, the riverbed and the left bank lie near the DC 180A communal road.

Fig. 5. The degradation phenomena of the riverbed in Zone 3, "Chiosa" after the flood in June 2016 on the Tazlăul Sărat River: a - upstream view of the river bed change and erosion; b - downstream view, highlighting oil piping and breaking the DC180A (photo Oct 2016)

The river develops a large hydraulic energy in the curve area, especially in times of flood, which generates a high value hydrodynamic force acting on

shoreline and shoreline construction. The unprotected bank of the Tazlăul Sărat River was eroded on a length of 80 m and an entrance to the shore of 0.5-5.0 m.

The erosion phenomenon has caused road breakage and traffic constraint. Crude oil pipelines and electric cables are located (buried) in the shore area. The erosion of the shore caused the pipes to be cut off and suspended (Fig. 5.b). The field analysis did not reveal the presence of shore defence.

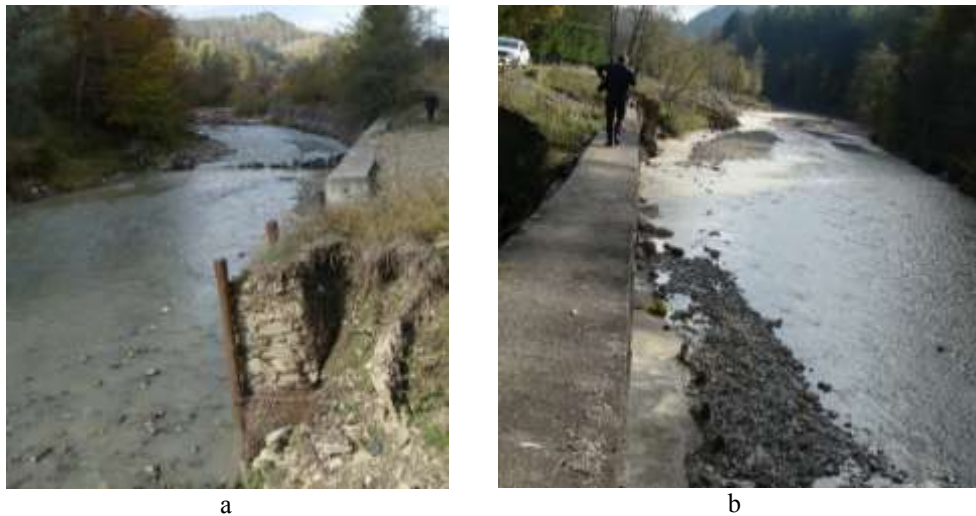
Fig. 6 - General view of the evolution bed of the Tazlăul Sărat River in area 4 "The Forest Canton Maxim": a - upstream view of the erosion area; b - downward view (photo Oct 2016)

*Zone 4. "Forest Canton Maxim".* The Tazlăul Sărat River bed has an approximately trapezoidal shape in this area, with a bottom width of about 16.0 m and a height up to the crown of the shore defence of 4.0 m. The left bank is vertical, being made by shore defence, and the right bank shows a slop slope 1: 0.5-0.8.

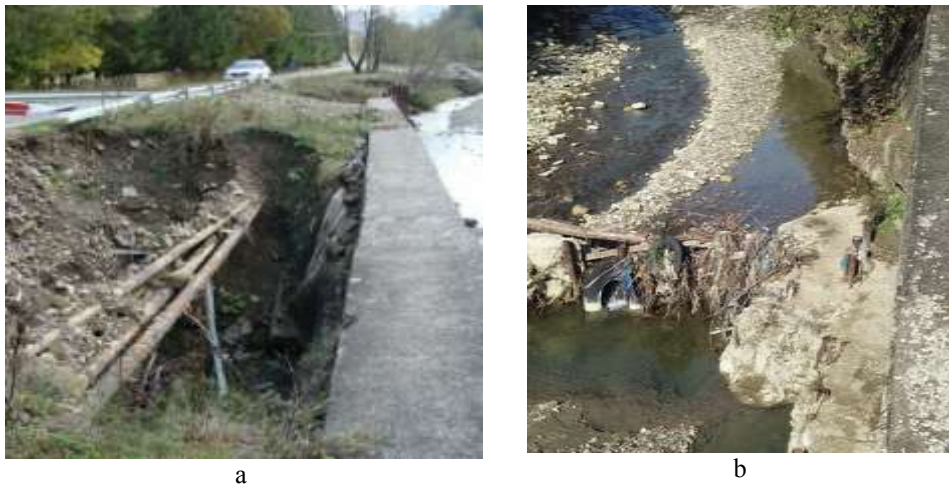
The first sub-area is located at the entrance to the analyzed riverbed sector, where the shore defence consists of a support wall made of plain concrete (foundation height - 1.00 m, elevation height 3.00 m, crown thickness 0.80 m). The water flow in the curvature area has a high velocity, causing an erosion phenomenon of the thalweg and the left bank.

The lowering of the thalweg has influenced the stability of the support wall foundation. The foundation has been scattered over its entire length over a relatively long time (Fig. 7.b). The water penetrated under the foundation and made several flow paths in the massive bed of cohesive material of the bed. Through these voids, an infiltration stream or pressurized water jet was formed, which

Fig. 7. Erosion phenomenon of the left bank after the flood in June 2016 on the Tazlăul Sărat River in Zone 4 "Forest Canton of Maxim": a - general view of the erosion zone behind the shore defence at the DC 180A limit; b - fencing phenomenon in the shore defence foundation area (Oct. 2016)

washed the filler material behind the support wall (Figure 7.a). The erosion phenomenon of the water jet continued to the ground (Fig 7). The erosion pit

behind the supporting wall reached a width of 4.80 m, out of which 1.90 - 2.00 m have developed in the structure of the road (Luca M., 2016).

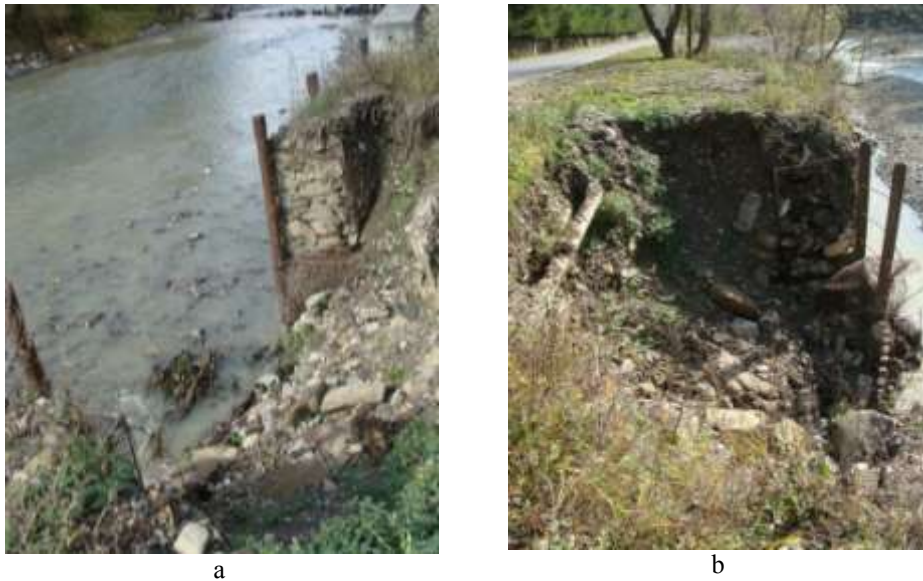
Fig. 8. Degradation of shore defence and erosion of the left bank of the Tazlăul Sărat River, the second erosion section, zone 4 "The Forest Canton Maxim": a - destruction of shore defence; b - upstream view (downstream river bed and unpacking of oil pipelines, Oct. 2016)

The second sub-area is located downstream to about 25.0 m from the first. The shore defence consists of a support wall made of gabion boxes. The water flow in the curvature area, guided by the simple concrete support wall, has created a strong erosion phenomenon here. The effect materialized through the destruction of the shore defence (gabion box support wall) on a length of about 15.0 m (Fig. 8). The erosion phenomenon continued until the road foundation (Luca M., 2016).

The degradation phenomenon of the left bank is influenced by the stable shape of the riverbed towards the right bank and by the limitation of the development of a meander to the left by the river. The hydraulic energy of the water stream turns into a mechanical deformation of the left bank in the curvature area. At the end of the road and on the bank of the river oil pipelines are buried. The erosion phenomenon of the bank and further on the road caused the pipes to be cut off and suspended. Pipeline degradation can lead to a strong oil pollution phenomenon on the Tazlăul Sărat River (Luca M., 2016).
