THE IMPACT OF LANDSLIDES ON THE DN15 NATIONAL ROAD IN THE AREA OF THE IZVORU MUNTELUI – BICAZ RESERVOIR

Claudiu Gaman¹

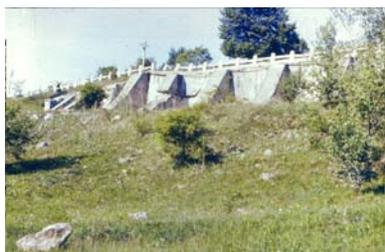
With all the efforts made for these consolidation works, in only one year from the construction finalization, in 1965, was witnessed the existence on the road of 70 sectors strongly affected by landslides (Fig 6).

Fig. 6. Consolidation with arches with pilasters on the affected DN 15 at Grozăvești

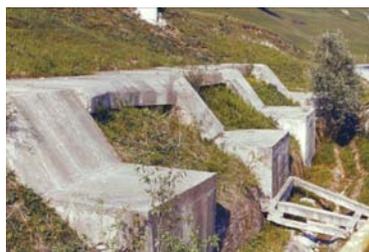
Fig. 7. Anchoring pile arches at the Vale Bubei viaduct

The impact of the landslides has been severe, overcoming the estimations of the constructors. The most affected areas have been Buba and Huiduman. In the torrential basin of Buba was needed to be emplaced canal embankments, drains, bank-sloping arcades, arches with pilasters and retaining walls (Fig. 7).

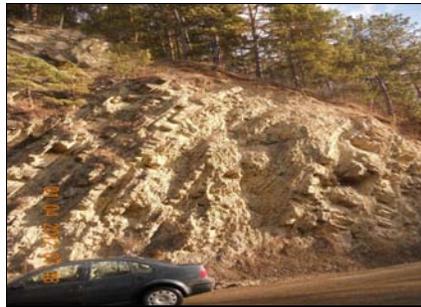
The DN 15 national road was constructed on a polygenetic slope modeled in strongly folded and intensely tectonized flysch rocks, in which the alternating strata (sandstones of different hardness, limestone, clays and marls) behave differently in relation to water action and freeze-thaw processes (Fig. 8).

Fig. 8. Strongly folded and tectonized flysch strata near DN 15

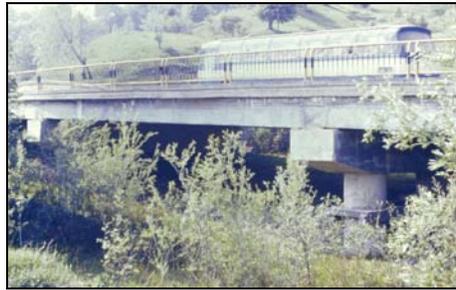
1. *Buba torrential catchment*, km 247+925 – 247+990. The energy discharges exerted by the landsliding deluvial mass on the road platform from the area provoked very large destructions. To allow circulation again was constructed a Benotto piles viaduct over the landslide body (Fig. 9). There were also undertaken

works for the consolidation of the landslide area uphill the viaduct and organizing water drainage. During the execution of the viaduct landslides have intensified and have broke the freshly installed concrete pillars from pile P2 at about 3 meters from the terrain level. Thus was needed to replace the broken parts, to reconstruct the pillars up to the initial level and consolidating them with strongly enforced sill plates. At the same time, upstream the viaduct was executed a consolidation with strengthening coffers united by reinforced concrete arches on pillars emplaced with the help of drop hammers. Later the P2 pile has been anchored for consolidation with the help of metallic grubs protected by concrete.

In 1980, approximately 3 years from the end of the constructions, was witnessed a reactivation of the landslide, which caused the destruction of the canal embankment at the exit from the viaduct.

Fig. 9. Valea Bubei viaduct

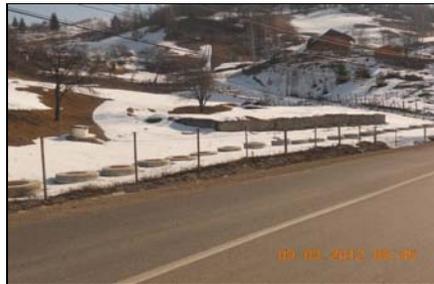
Fig. 11. Drain network on DN 15

3. *Huiduman catchment*, km 259+200-259+324. Here occurred reactivations of old landslides, mentioned in the geotechnical studies even from the design phase in 1958. During 1965 was constructed a legged abutment wall which was again affected by landslides in 1969. The landslides from the area have a distinct delapsive character, being triggered from downstream the road, from the margin of the lake and ending upstream de road. It is considered that the large variations of the lake level decisively contribute to a permanent state of terrain instability, due to the short distance to the lake shore. Thus have been strongly affected a series of buildings upstream the road which have later been demolished. The road has been consolidated with pillars in the area of the abutment wall, which was continued

later with arches on pillars. At the same time was constructed a longitudinal drain under the road ditch which collects the smaller drains from the area (Fig. 11).

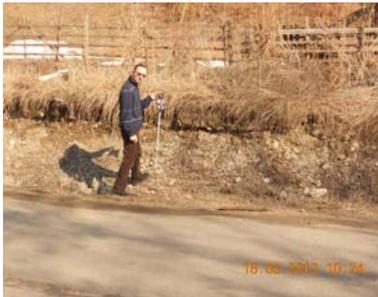
During 16.02 - 18.03.2012 were conducted a series of field observations in the area and have been observed a reactivation uphill Grozăvești viaduct, which led to a displacement of buildings from the near vicinity and a subsidence of the DN 15 road platform of over 70 cm in comparison to the initial level (Fig. 12 and 13).

Fig. 12. Subsidence of DN 15 road platform at Grozăvești

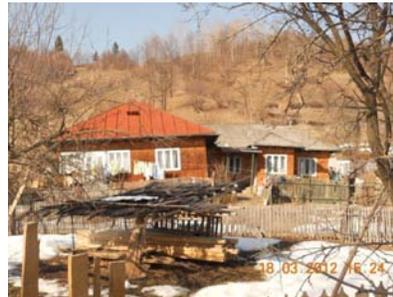
Fig. 13. Building displacement, Grozăvești

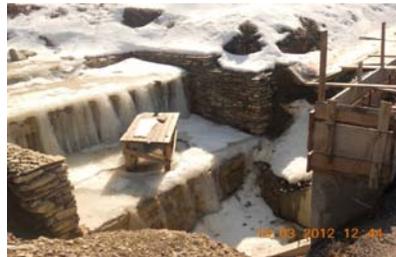
In the same period it was noticed that on the road from the dam to Poiana Largu all the brooks were depleted although at the end of the second decade of February 2012 were registered heavy snows (Fig. 14). Immediately downstream Vârlan brook were conducted some flood control works for a small torrent that had affected the road platform (Fig. 15).

Fig. 15. Flood control works downstream Vârlan brook
