DOI 10.1515/pesd-2017-0026

PESD, VOL. 11, no. 2, 2017

## **ANALYSIS OF PHENOMENONS WITH HYDROLOGIC LARGE RISK IN THE HYDROGRAPHIC BASIN OF THE TROTUȘ RIVER**

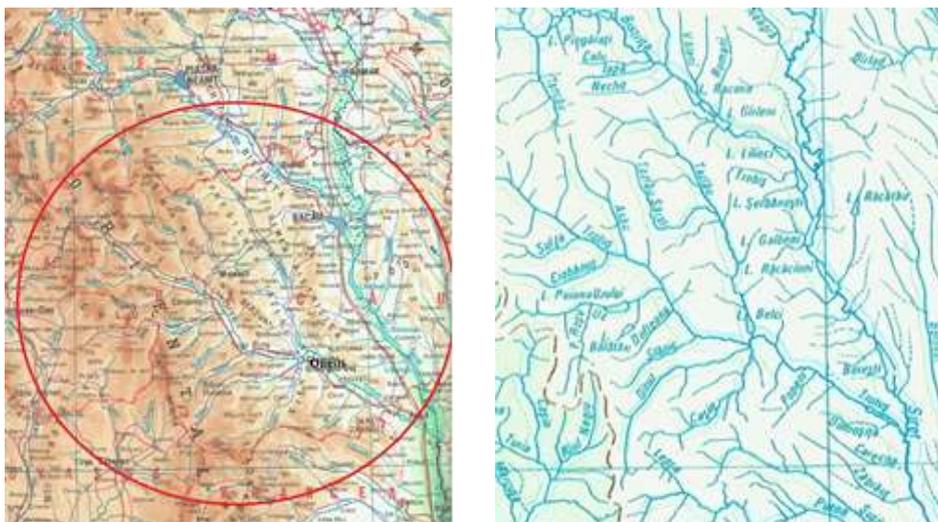
Fig. 1. Location of the study area in the Siret catchments area: a - details of the relief areas in the Eastern Carpathians; b - the hydrographic network characteristic in the study area

The tributaries on the right are more numerous and have larger hydrographic areas (Uz - 469 km<sup>2</sup>, Oituz - 337 km<sup>2</sup> and Cașin - 308 km<sup>2</sup>). They drain higher mountain areas and have a richer leak. The most important tributaries on the left are Asaul - 208 km<sup>2</sup> and Tazlăul - 1104 km<sup>2</sup> (Fig.1).

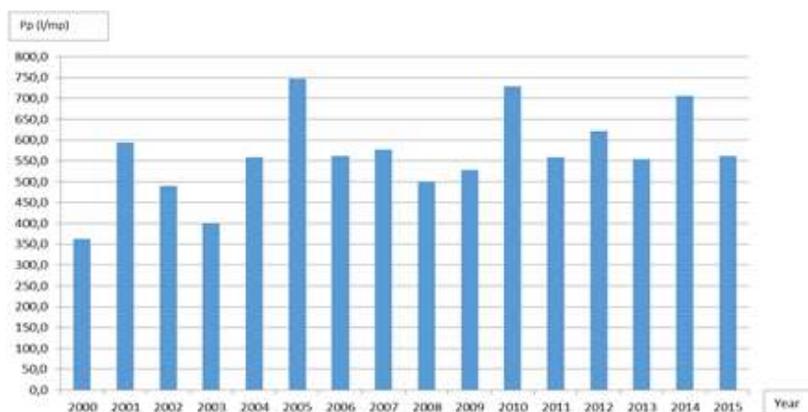
Fig. 2 The variation graph of the annual precipitation in the period 2000 - 2015

The research used climatic data taken from the meteorological stations located in the Trotuș River Basin. The meteorological data were taken over the variables required by the research field (5 - 65 years). The analysis carried out [for the 65year period revealed the fluctuation of the study data for different periods of time. The data has been processed and transposed graphically during the research period (Avram, 2016). A special analysis was made regarding the variation of the annual rainfall from 2000 to 2015 at the Tg, Ocna hydrometric station in the Trotuș hydrographic basin (Fig. 2).

The precipitation analysis highlighted a series of positive or negative variations, but there is no clear trend towards growth or diminution. Against the background of global warming in recent years, there is no trend towards the evolution of rainfall. The analysis performed over two long time periods (1950-1983 and 1984-2015) shows that the frequency of exceeding the multi-annual mean value was higher (20 cases) in the first period than in the second period (11 cases).

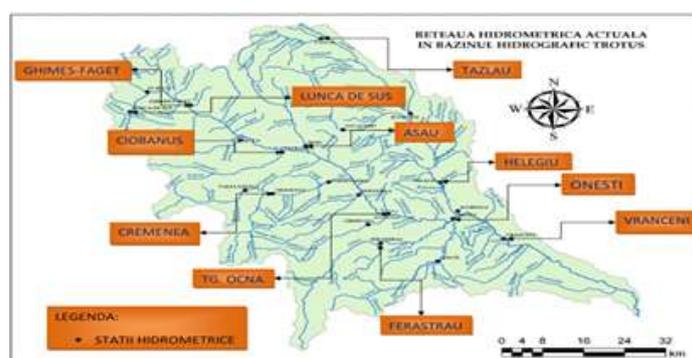
Fig. 3. Hydrometric stations network in the Trotuș river basin (ABA Bacău)

Hydrological data were collected from hydrometric stations located in characteristic sections on the Trotuș River and its tributaries (Table 1, Fig. 3). A special analysis was carried out for data from the hydroclimatic risk periods, where variable periods of time (10 - 65 years) were considered. The analysis considered the average, maximum and minimum multiannual flows between 1950 and 2016 (Avram, 2016). The Trotuș River and its affluents analyzed the variation in the average annual flows versus the multiannual average and the frequency of overflows with the required calculation probability.

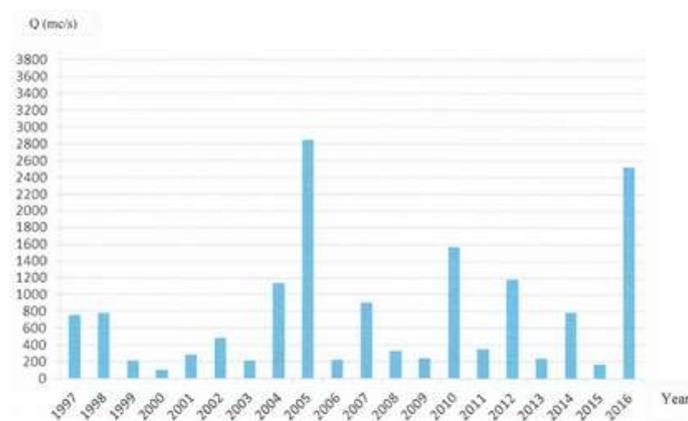
Fig. 4. The variation in the maximum annual flows from 1997 - 2016 at H.S. Vrancea

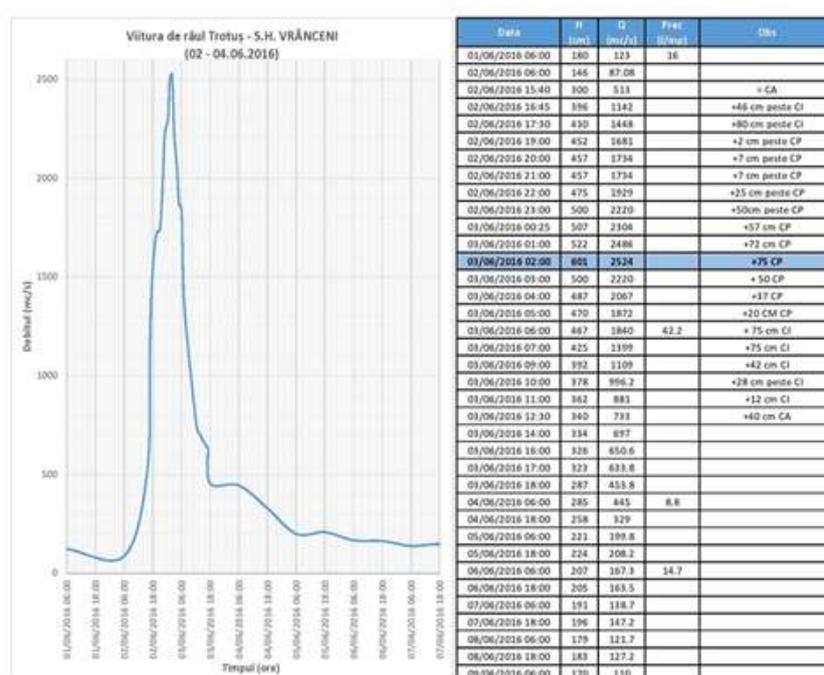
Fig. 5. The flood shelter of June 2016 R. Trotuș, H.S. Vrânceni

The Vrânceni hydrometric station is located downstream of the confluence of the Trotuș River and the Tazlău River. The surface of the Vrânceni hydrometric station is 4092 km<sup>2</sup> and represents 92% of that of the Trotuș hydrographic basin (4456 km<sup>2</sup>). For each flood, the hydrograph was drafted at the hydrometric flow measurement station (Avram, 2016). The results of the debit processing at the Vrânceni Hydrometric Station for June 2016 are presented in Fig. 5.

4. The flood with a probability of calculation of 1.0% and a value of 2542 m<sup>3</sup>/s produced in June 2016 on the Trotuș River presented one of the highest flows recorded at SH Vrânceni.

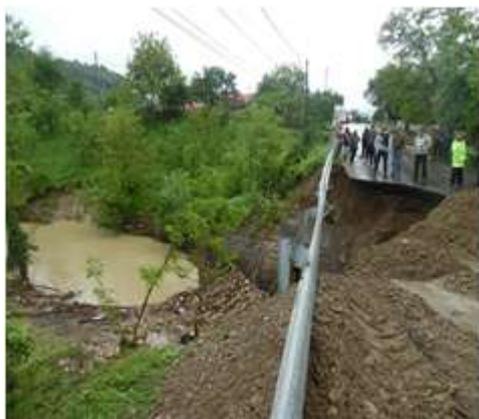
Fig. 6. General view of a landslide, the Cașin River, with the degradation of the road (Avram M., 2016)

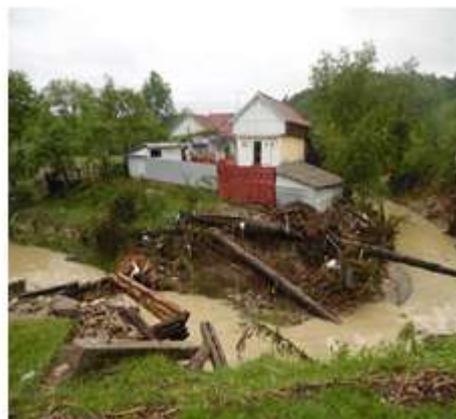
Fig. 7. The degradation of the riparian area on the Flooding Cașin River in June 2016 (Avram M., 2016)

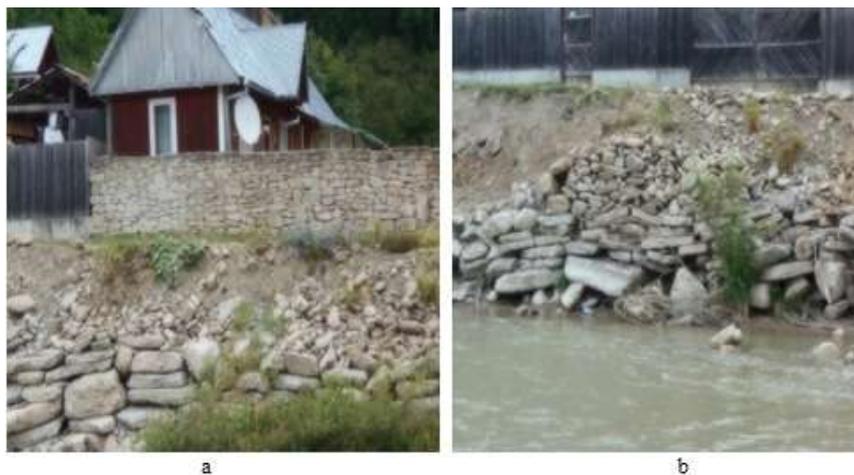
Fig. 8. Erosion of the Trotuș River in June 2016: a - erosion in the area of dwellings; b - the erosion of the county road (Avram M., 2016)
