STUDIES AND RESEARCHES ON MONITORING BY GIS MODELS EXTREME PHENOMENONS IN THE POPULAR CENTER

Key words: database, building classes, hydrants, fire areas

3. Case Study - Analysis of the fire protection and fire-fighting phenomenon for the "Aviation Plateau" area, Iaşi Municipality

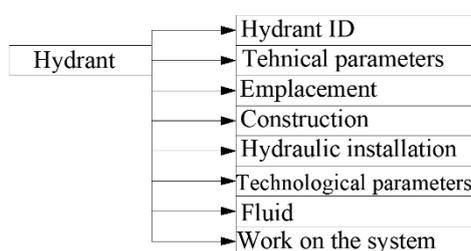
Fig. 3. Characteristic layers of hydrants in the GIS model

Each layer for the hydrant network has graphic information attached to the construction and hydraulic features. Data collection on hydrants is collected during the design, installation and operation phase. By developing a GIS model, it is important to have the tables attached to them with other types of important information in the interpretation and query process. In the case study, the pipeline network initially had 14 hydrants. Each hydrant had attached location information, diameter, flow, construction type etc. On the basis of the field studies, information was added regarding the land quota, flow, pressure, material, year of commissioning, photos, performers, works done for their rehabilitation and improvement etc.

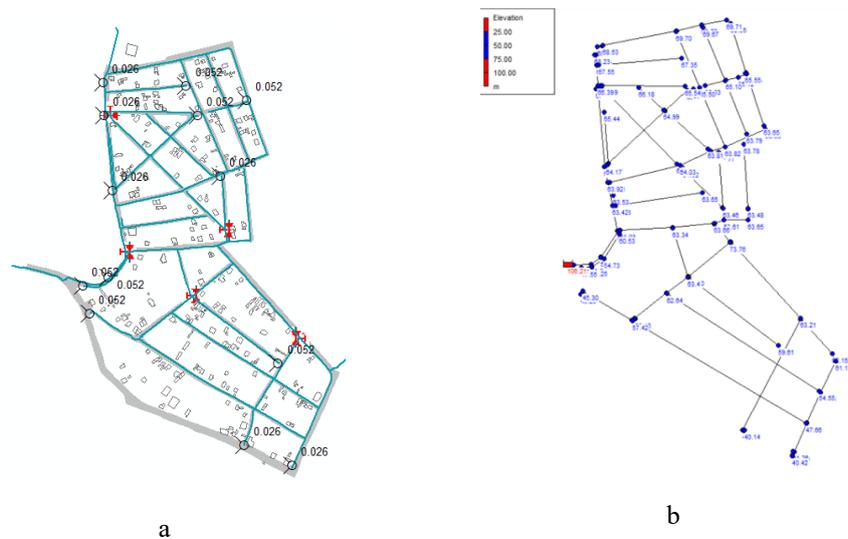
Within the study area it was determined (by simulation in the Epanet program) that the fire base demand falls between 0.026 l / s and 0.052 l / s. Thus, it can be seen that in areas where land has a higher share demand is higher. In the study area there is a significant difference (Fig. 5), with variations from 40.14 m in the south - west to 69.71 m in the north

Fig. 5. Requirements analysis in the study area: a - water demand (l / s);
b - the plot of land (m).

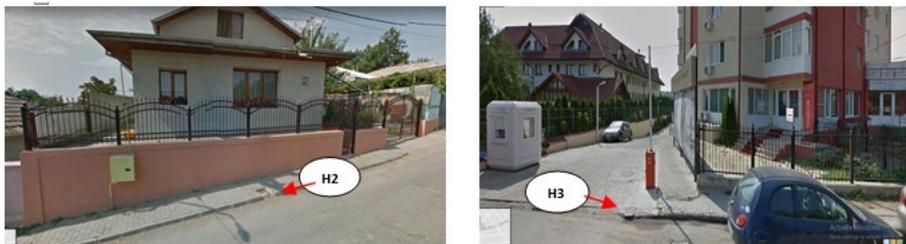
- the hydrant with H2 code, located on Holboca Street, is located on the road, is not signaled, and the cover is covered with dry vegetation and paving slabs;

- the hydrant with the H3 code, located on the Airport Street, near the Porumb Street, is located in the area of some residential buildings with average height $P + 4E$, index A and low fire risk category;

Fig. 6. Identification of hydrants with the code H2, H3, in the "Aviation Plate"

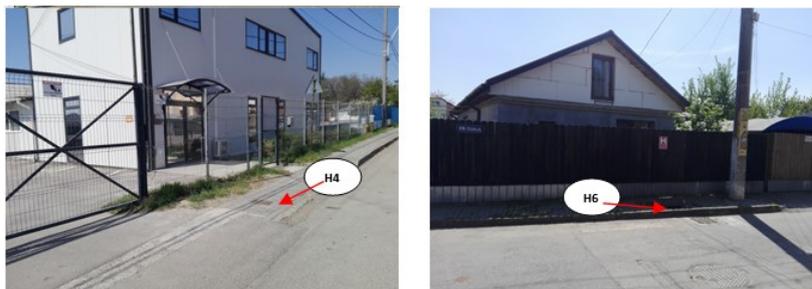
- the hydrant with the H4 code, located on the Airport Street, near the intersection with the Protopopescu and Vulturi streets, is positioned on the

sidewalk and is marked accordingly; the hydrant has a diameter of 100 mm, with a land area of 66.41 m, and in its vicinity is a CIE type building, with a medium height $P + 1E$, with a mapping index B and a major risk in case of fire. The building is the headquarters of a company that works with paper, metal, plastic, wood, etc. (Fig. 6);

- the hydrant with the H5 code, located on the Airport Street, was not identified on the ground;
- the hydrant with the H6 code, located on Ceahlău Street, is positioned on the sidewalk, but there has been a marked deterioration of the structure and the hydraulic installation; the H6 hydrant is partially covered with asphalt, so in the case of a fire, the layer must be removed beforehand, the operation impedes the firemen's task (fig. 7);

Fig. 7. Identification of hydrants with the code H4, H6 in the "Aviation Plate"

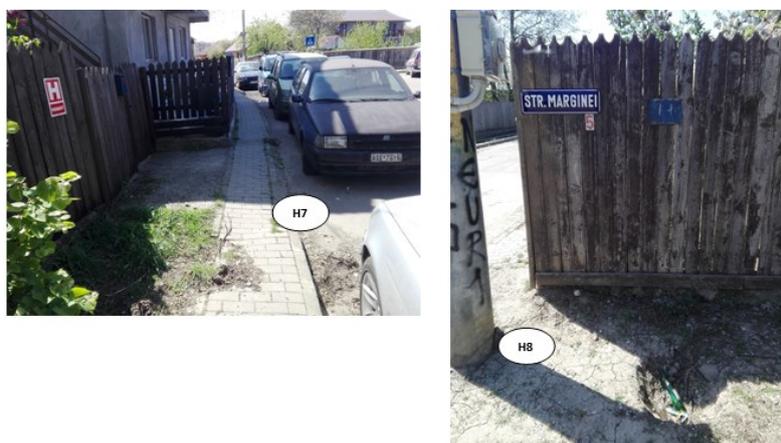
- the hydrant code H7, located on Porumbul Street, near the intersection with the Nisipari and Eagle streets, was not identified in the field; the field analysis shows (Fig. 8) the location where the H7 hydrant should have been placed and where only the signaling sign remained;

- the hydrant with the H8 code, is located on Marginii Street near the intersection with the streets of Obreja and Vulturi (secondary pebbled street); as with the H7 hydrant, it was not found in the field (only the signpost is in position);

Fig. 8 Identification of hydrants with code H7, H8 in the area "Aviation Plate"

From the field research, it emerged that of the 14 hydrants mentioned in the documents only eight hydrants were identified, one of which was canceled. By field research, the eight identified hydrants were found to have pavement location, not adequately signaled (H2, H9 hydrants), or signaling plate missing (hydrant H14). In the case of hydrants H2, H6, H9, H12 the state of degradation of the structure and of the hydraulic installation was found. Six hydrants were not identified in the field. For H7 and H8 hydrants, only the signaling plate was identified (Fig. 8).

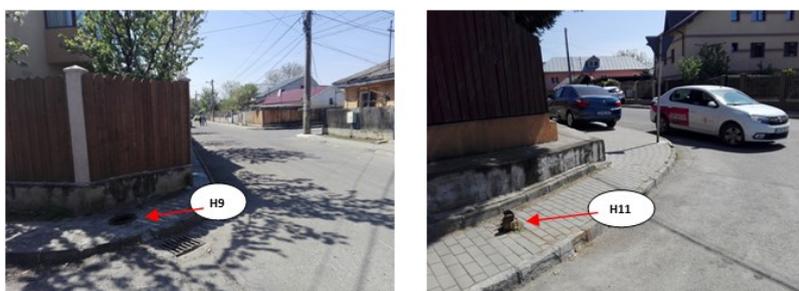
- the hydrant with the H9 code, located on Moți street near the intersection with the Obreja street, has a pavement location; the hydrant is partially degraded (no cover) and the sign is missing; the hydrant has a diameter of 100 mm, with an area of 63,92 m and an application of 0,026 l / s;

- the hydrant with the H11 code, located on Aurel Vlaicu Street near the intersection with Seven People Street, has its pavement location; the hydrant was canceled, and on the ground we only identified a part of its facility;

Fig. 9 Identification of hydrants with H9, H11 in the "Aviation Plate" area
