## OBSERVATIONS ON THE SEPTEMBER 2007 FLASH FLOOD IN THE TECUCEL RIVER BASIN

**Abstract.** The meteorological and hydrological events of September 5, 2007 in southern Moldova remained in the collective memory, mainly due to flash flood formed in the Tecucel basin, phenomenon that led to inundation of much of the city of Tecuci and death of three people in this community. This event was the first case, after the catastrophic floods of 1970, when a major city of Romania has been seriously affected by a river overflowing. Although the natural hazards represented by the heavy rains affected a much wider area (and were more intense in other hydrological basins), increased vulnerability of the confluence area of this tributary with Bârlad river (density of housing, infrastructure and economic activities in the flood) led to a increased risk to the area, resulting in a natural disaster far exceeded the previous events in rainy years 2005-2007. Field observations made in September 2007, both during the events and the subsequent analysis of their long-term effects may help to understand how climate risks caused by heavy rain of severe convective origin can be mitigated, especially in small

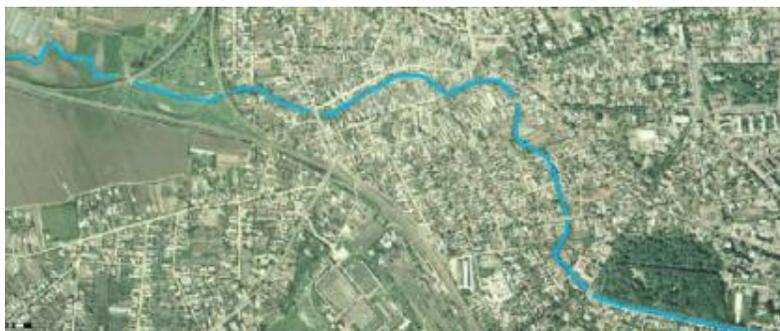
Fig.2 – The natural course of the Tecucel stream (highlighted) inside the municipality of Tecuci

This strong meandering of the Tecucel waterway (fig. 2) in the inner city in contrast to linear flow, quasi-channeled profile, which characterize the rest of the river course through its catchment area determined, most likely, the huge size of the area affected by flooding and enhancing vulnerability thus generated by this natural risk. Only on the last kilometers the stream is properly channeled, which significantly reduces the risk by an order of magnitude to residents in the area southeast of the town.

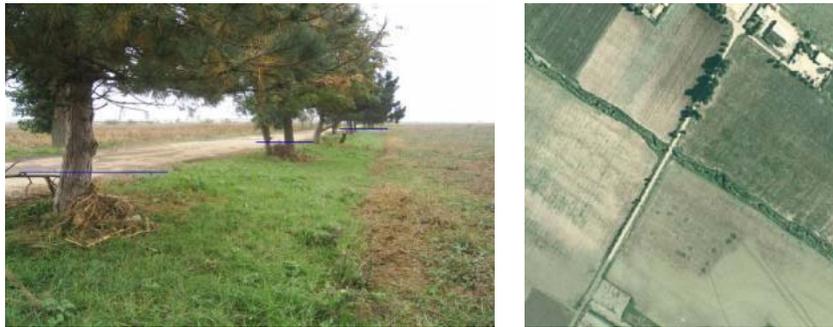
Fig. 8 - Analysis of flood damage at Cozmesti, orthophotomap of studied area

Traveling by foot along the Tecucel river from Nicorești to Tecuci we can find in a generally flat area, the paved road leading to the former SMA Cosmești perpendicularly crossing the river and flood plain, this road was clearly damaged by the flood water. The witnesses' accounts to the flood (local workers) can be combined with crop and road damage and the height of the waste hauled to compute the maximum flow of the flash flood, flow can be estimated around  $230 \text{ m}^3 / \text{s}$ .

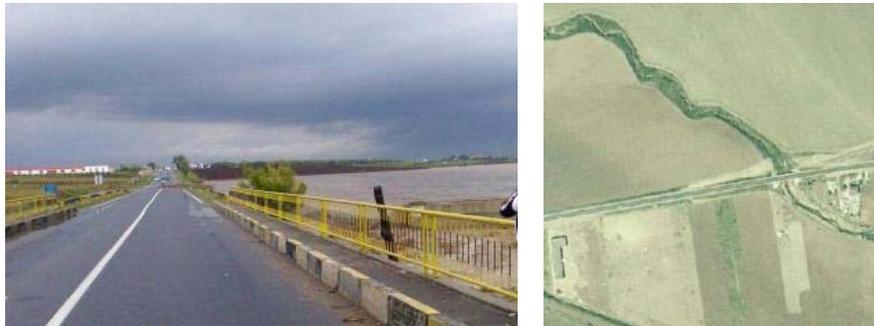
Fig. 9 –Appearance of the flash flood before Tecuci (bridge over DN24) ortophotomap of location

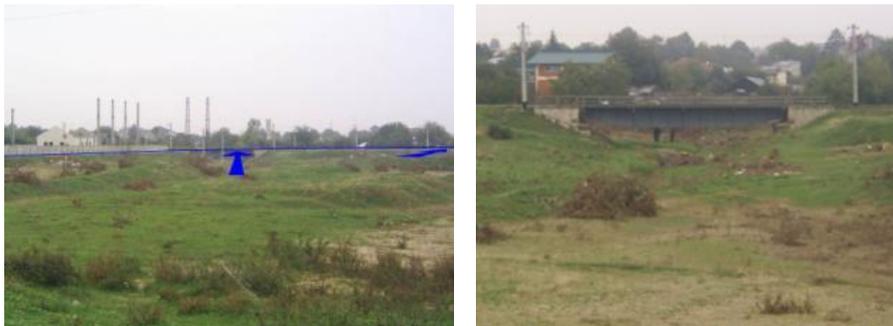
Fig. 10 – Estimated flood level and direction of the flash flood upstream Tecuci (determined after traces of the flood and witnesses account), detail the railway bridge

Both upstream this bridge, but also downstream of this initial chocking point, behind the railway bridge triangle connecting the North and South stations of Tecuci to the link to Marasesti, huge temporary reservoirs were caused by the clogging with silt and waste of the bridge spans. The clogging of these bridges (especially the last railway bridge, fig. 10) or defective flow through them (the bridge on National Road 24 was partially blocked by the foundations of an abandoned bridge) have limited the extent and velocity of the initial waves of floods and induces a state of false security in the town population. The final flash flood surpassed both the national road and railway embankment (fig. 11), powerful

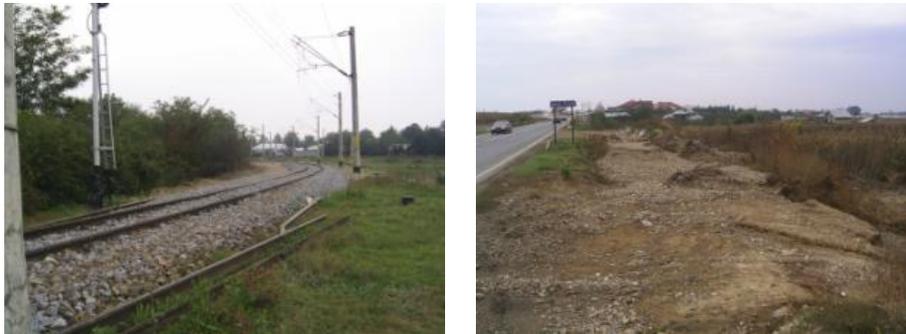
eroding them and releasing the temporary dams into a raging torrent that violently entered the town of Tecuci.

Fig. 11 – Erosion of the embankment of the Barlad-Tecuci railway (which needed urgent repairs for a distance of 300m) and that of the DN24, both man-made structures forming a temporary dam in the flood path

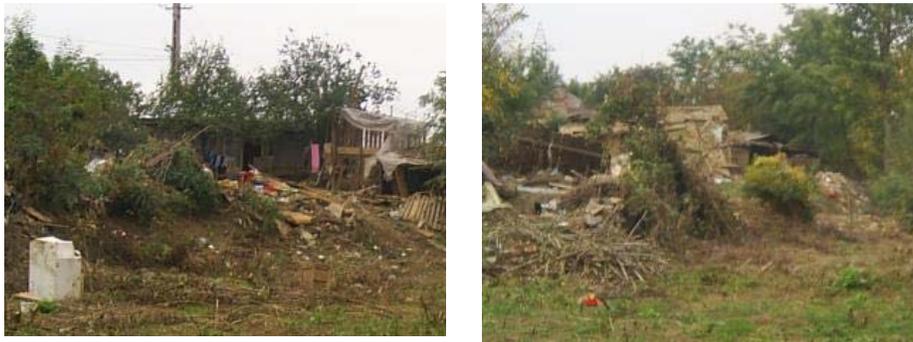
Fig. 12 – Typical flash flood damage caused by the Tecucel flood just after it entered Tecuci

After the flash flood surpassed and destroyed the temporary dams caused by the clogged bridges, it burst into Tecuci at an astonishing speed and destructive force, causing severe damage (total destruction) to the nearest houses (fig. 12). This kind of direct damages (caused by high speed torrential flow) continued only until the first road bridge, a bridge with a very small span, which was blocked entirely and the flow also stopped by a nearby structure carrying central heating pipes (fig. 13). Because this obstacle had proved to be extremely strong, flood waters started invading the side streets (fig. 14), leaving the river bed and flowing

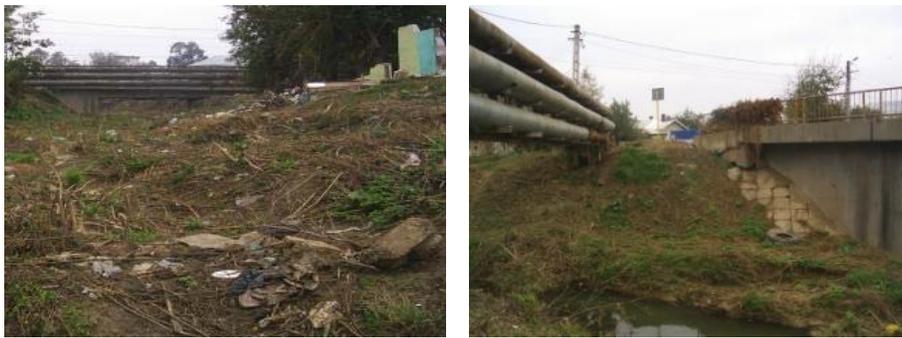
Fig. 13 – The heavy concrete bridge and nearby central heating ducts that effectively blocked the flow of the flash flood

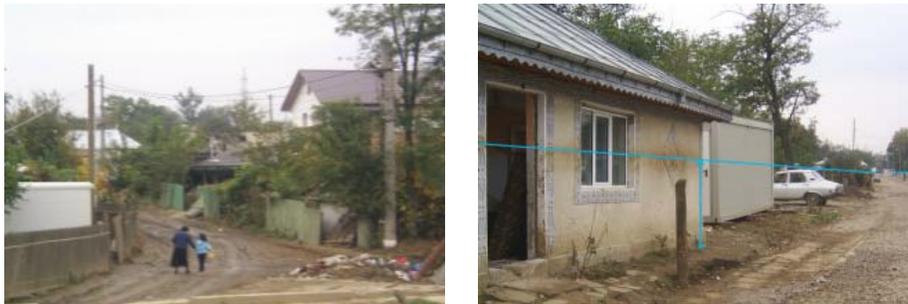
Fig. 14 – The flooding of the side streets besides the Tecucel riverbed and clues to the height of the floodwater.

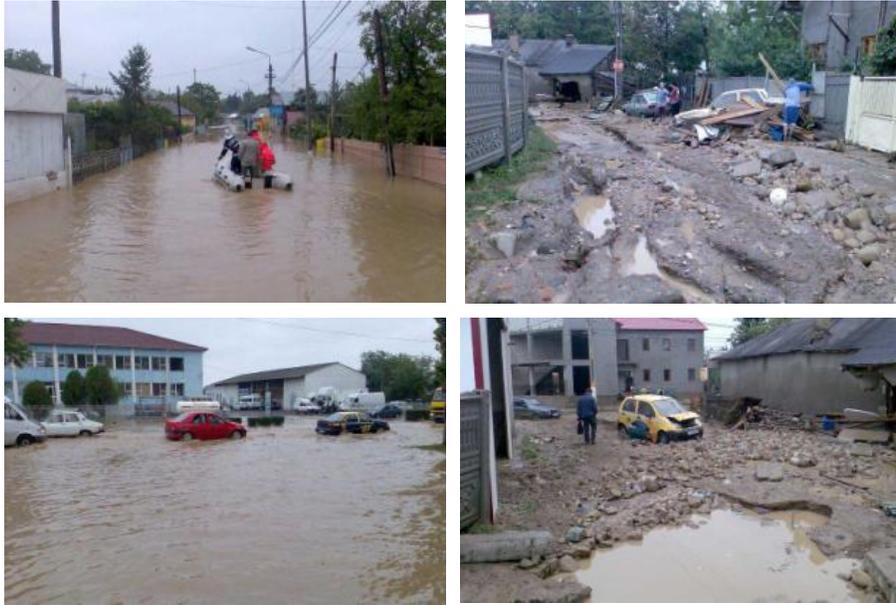
all over the city center (fig. 15). This dispersal of the water flow resulted in the annihilation of its power and speed but also established a new temporary lake, this time just inside the city. This way we can begin to understand the size of the affected area, with hundreds of homes being flooded all over the town but fortunately less violently because the energy of the flash flood was already dissipated.

Fig. 15 - Flood damage in Tecuci: left, the area affected by progressive flooding, right: flash flood affected area

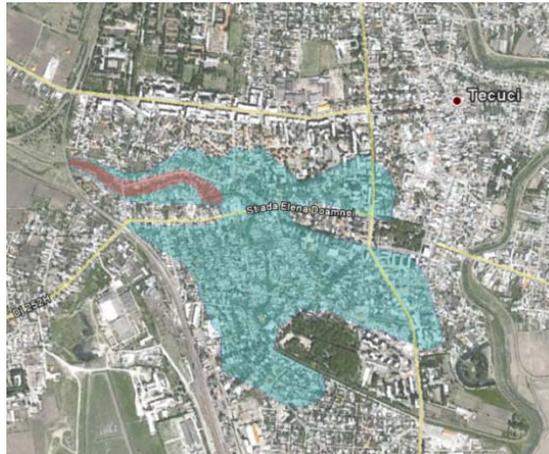
All these features of the flood have led to differentiation in the damages and casualties produced (fig. 16): a rather limited area in which the destruction was total (resulting also in casualties) caused by the specific manifestation of an flash flood and a huge area (covering almost two thirds of the town) in which damages

Fig. 16 – Distribution of the damages in the town of Tecuci: in red, heavy flow affected area, in blue the area affected by stagnant water (background image Google Earth)

were caused by gradual flooding of land and housing, and the stagnation of these flood water, a more specific type of destruction slow floods on large rivers, equally destructive in the long term but posing a lot less danger to the inhabitants (which were able to walk and drive through the flood waters).
