## HYDROLOGICAL RISK CHARACTERISTICS OF THE OZANA RIVER VALLEY

Marina Iosub<sup>1</sup>, Dan Lesenciuc<sup>2</sup>

**Abstract.** The occurrence of hydrological risk phenomena is conditioned by a series of factors, related to climatic, geologic, geomorphologic, pedologic, vegetal aspects etc., which are specific to the drainage basin of the Ozana river. The hydrological risk that has a major impact upon the human settlements in the area, is conditioned by the presence of floods which frequently occur in the rivers flood plain. In this present study, we have emphasised the floods that took place between 2005 and 2008, including the *maximum maximorum* run-off rate of 456 m<sup>3</sup>/s, recorded at the Dumbrava hydrometric station, in 2005. By utilising the data gathered from the hydrometric stations, located on the Ozana river valley, we have analysed the propagation of the flood waves generated in the three sectors of the drainage basin: the upper, middle and lower sector. After the analysis, we have observed the fact that the area that was most affected by the floods is the upstream river sector, where numerous households and roads have been flooded. Another aspect of the hydro

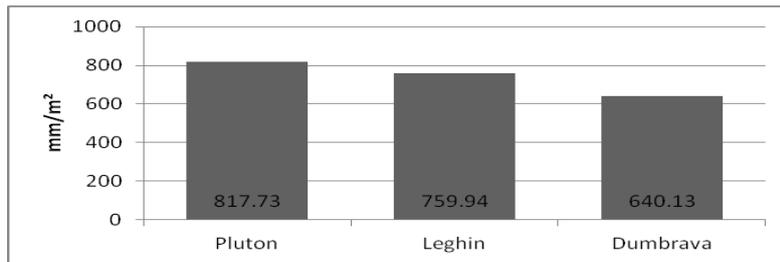
Fig 3 - The average, multiannual rainfall in the Ozana drainage basin (1970-2009)

decreases from the west (817,73 mm at Pluton), to the east (640,13mm at Dumbrava),(Fig no. 3).

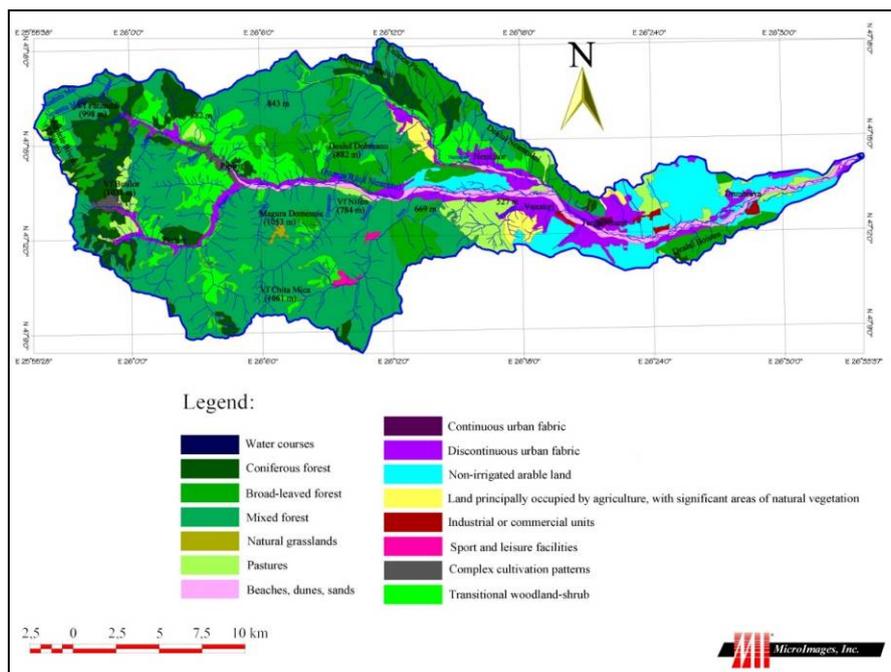
Fig 4 - Map of the main types of vegetation in the drainage basin of the Ozana river

The forests form the vegetal cover, which has the largest spread in the mountain area, including on the subcarpathian peaks, occupying 64% of the total drainage basin area (Fig. no. 4). On the Ozana river valley, many areas are heavily

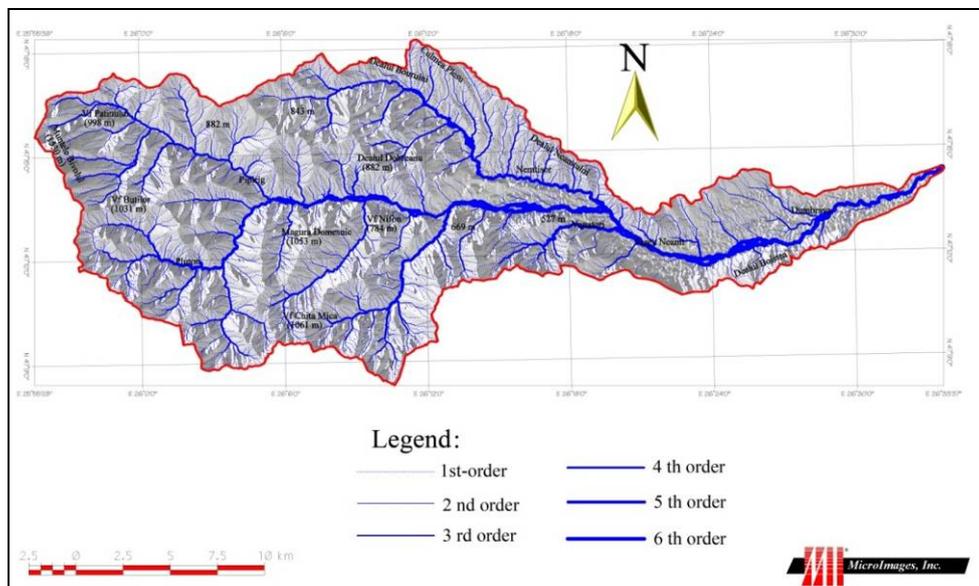
Fig 5 - The Horton Strahler hierarchy for the river network in Ozana's drainage basin

long. Ozana's river course runs through the Pipirig, intramontane depression and the Ozana – Topolița subcarpathian depression, which are two depressions well populated, where the households are positioned mostly in the river's flood plains. The right hand side main tributaries of the river are Pluton, Domesnic and Secu, and on the left hand side, the main one is Nemțișorul (also being the most important tributary of Ozana). Ozana's drainage basin has a total surface of 419.35 km<sup>2</sup> and a total length of the drainage network of 1567,13 km, with an average density of 3,74 km/km<sup>2</sup>. The hydrological network has been hierarchised conforming to the Strahler model, which revealed six river orders (Fig no. 5).

We have made the Horton-Strahler river hierarchy map in order to see the river orders that are mostly responsible for generating the biggest floods. Along the entire Ozana river basin (upstream of its outlet into the Moldova river), 6 river orders have been identified, at the study scale, of 1:25.000

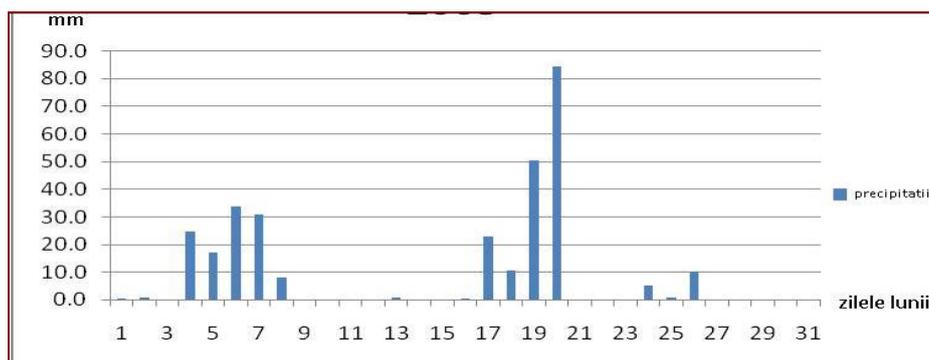
Fig 6 - The quantity of rainfall for august 2005 at the Leghin hydrometric station

In 2005, the amount of rainfall that has fallen was very big, this year being considered a very rainy year, because the rainfall quantity has overpassed the average, multiannual rainfall quantity. That year, the biggest amount of rainfall has fallen between 17 and 20 august (Fig no. 6). Because of the short period of time for that large amount of rainfall, the drainage basin had no possibility to retain the immense water volume, favourising the occurrence of the flood. The total amount of rainfall, on a basin-based calculation, in august 2005, reached 288,3 mm at Pluton, 301,6 mm at Leghin, 226 mm at Dumbrava. The flood that took place in august was recorded at all three hydrometric stations on the Ozana river, therefore favourising the possibility to analyse the scale that the flood reaches in the territory and the manner it affects the households located on the river flood plain. At the first hydrometric station (at Pluton), the flood had a maximum run-off capacity of 45,5 m<sup>3</sup>/s, recorded on the 20th august (1:45 A.M.). The flood started on the 19th of august (9:20 P.M.), T<sub>c</sub> = 4 hours and 35 min., with an interval of approximately 3 hours, during which the maximum run-off capacity mantained at the same values, T<sub>s</sub> = 5 hours, T<sub>t</sub> = 9 hours 35 min, W = 2026 m<sup>3</sup>, h = 270 cm (Fig. no.7).

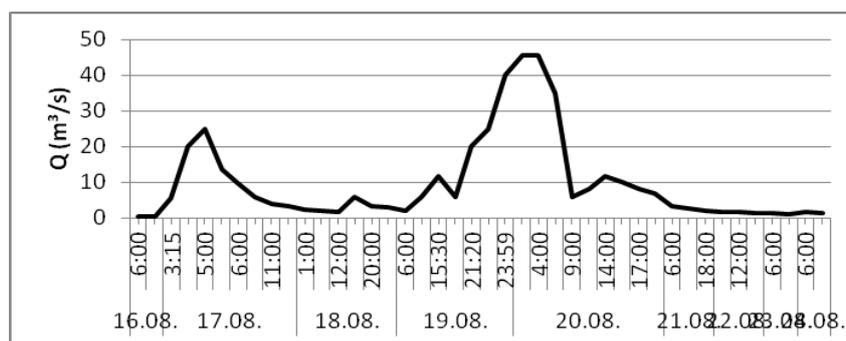
Fig 7 - The hydrograph for the august 2005 flood, at the Pluton hydrometric station

Due to the intense rainfall that occurred in that period, the hydrograph of the flood reveals several flood waves with a lower amplitude, by comparison to the main flood wave. This pattern has repeated on the entire course of the Ozana river, in the places where the flood plain has been flooded, and agricultural land was affected, households and national or county roads have been damaged. The analysed flood complies with the complex type of floods, taking place at the outlet of several tributaries of the Ozana river.

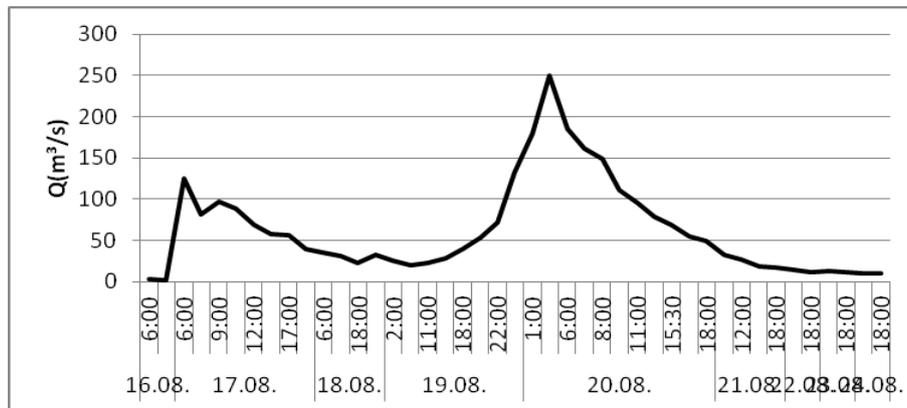
Fig no 8. The hydrograph for the august 2005 flood, at the Leghin hydrometric station

At the Leghin hydrometric station, the run-off capacity was influenced by the water that was brought by several, important tributaries, such as: Domesnic, Pluton etc. The maximum run-off reached 250 m<sup>3</sup>/s, this value being recorded on the 20th august. The starting point for the biggest flood wave was also recorded on the 19th

of august (11:00 A.M.) and the lowering of the run-off capacity took place on the 22nd august (6:00 P.M.) (Fig no. 8). The flood had  $T_c = 20$  hours,  $T_s = 38$  hours,  $T_t = 58$  hours,  $W = 108709$  m<sup>3</sup>,  $h = 220$  cm. Like the station at Pluton, this flood wave was succeeded by another wave which had a much lower intensity, but had already damaged the defense capacity against floods.

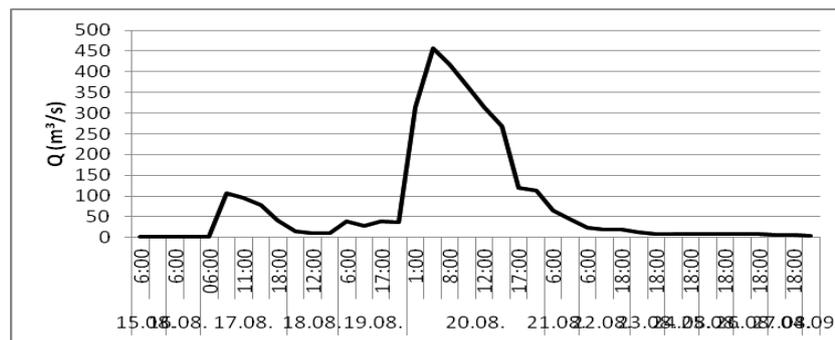
Fig. 8 - The hydrograph for the august 2005 flood, at the Dumbrava hydrometric stations

At the Dumbrava hydrometric station, the rising of the run-off capacity began on the 19th of august (6:00 P.M.), reaching a maximum value of 456 m<sup>3</sup>/s on the 20th of august (6:00 A.M.), with the maintaining of a run-off capacity of over 400 m<sup>3</sup>/s, for two hours (Fig no. 9). The occurrence time of this flood wave was of 56 hours, of which  $T_c = 12$  hours,  $T_s = 42$  hours,  $W = 145\ 266$  m<sup>3</sup>.

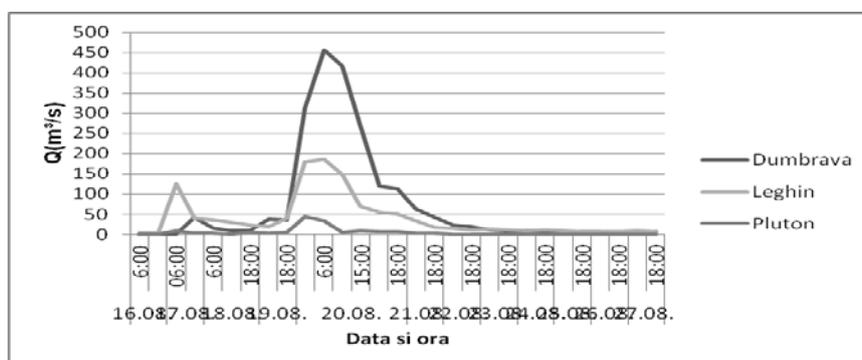
Fig. 9 - The hydrograph for the august 2005 flood, at the Pluton, Leghin and Dumbrava hydrometric stations

By correlating the recorded data at the three hydrometric stations, we have obtained a graphic representation, that emphasises the time/space distribution of the analysed flood. The flood propagates progressively through space, at intervals of tens of minutes. The maximum run-off capacity has been recorded at Pluton, at 1:45 A.M., at Leghin (20 km downstream) the maximum run-off capacity was recorded at 2 A.M. and at Dumbrava, the maximum was recorded at 6, in the morning (Fig no. 10). The floods that occurred during this period, on the Ozana river, affected several urban and rural settlements, such as Timișești (Dumbrava, Plăieșu), Târgu Neamț (Blebea village and Humulești – overflow, gully erosion and dam rupture in the Cetatea Neamțului area), Vânători-Neamț (Vânători, Lunca - overflow) and Pipirig (Pipirig, Leghin, Pițiligeni, Boboiești, Stînca, through gully erosion, streams and overflow), the DN 15b national road, at the Stînca sector, Pipirig village was seriously damaged, because of the erosion of the left river bank, on a 200 meter section. In the Pipirig village, 4 DN bridges have been damaged, 20 national interest bridges and 14 local interest wooden bridges, 0,5 km of village streets, 20 households (and another 103 in danger of flooding), 4 ha of pastures and arable land, being flooded. For the Vânători village, the water has risen over the flood water mark, leading to the flooding of 25 households, 100 m of national road, 1 national interest bridge, 2 km of local importance road in the Lunca village, 10 ha of pastures and 5 ha of arable land. At Târgu Neamț, the protection dam on the right bank was damaged, and several households were flooded. Around the Humulești village area, the left river bank, which had no protection from dams, was eroded, and the river changed its course towards the left side by 4 meters, reaching the company buildings placed on its bank. Around Blebea village, the overflow of the water affected a few households and 20 ha of farm land and the electric grid was damaged, due to the collapsing of a few electric posts. (information from "*Report regarding the effects of floods and dangerous, meteorological phenomena, in 2005*" and from the data offered by the county committee for emergency situations).

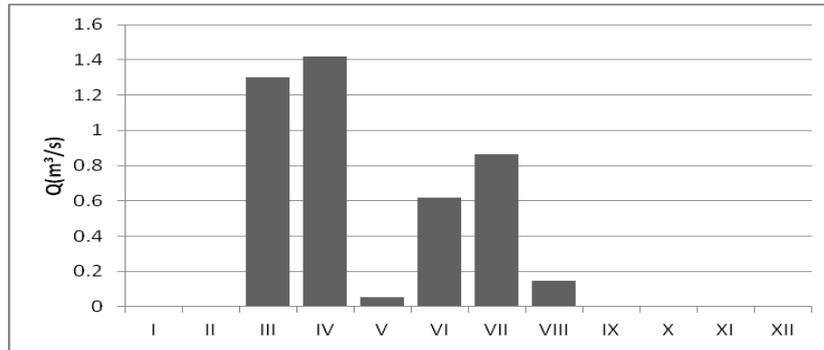
Fig. 10 - Mean monthly flow recorded at Dumbrava hydrometric station

The river runs dry, mostly in the years during which a pluviometric deficit is recorded. The months when the river does not surface anymore and looks that it has run dry are, mostly winter months and occasionally, if the draught periods are extended, this phenomenon can occur even in summer months, when the run-off capacity is extremely low. One of the most important cases of the river running dry in the Dumbrava sector, was recorded in 1986, when out of 12 months, half of them had a run-off capacity equal to none, this having a very negative impact on the local fauna. (Fig no.11).

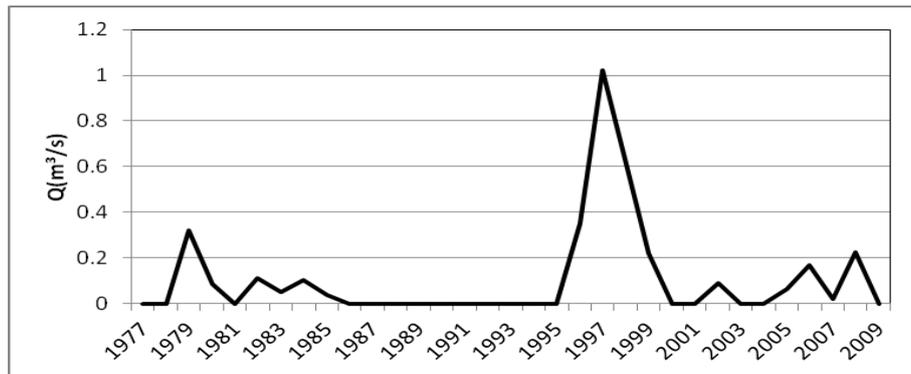
Fig. 11 - The frequency of the years during which the Ozana river has run dry (Dumbrava hydrometric station)

The risk associated to the river running dry is a permanent threat, and such lowered run-off capacities are recorded every year, with a lower or greater amplitude. The lower sector of the river has been under hydrometric observation for 33 years, and the running dry of the river has taken place in 20 of these 33 years of measurements (Fig no. 12). The longest period of time during which the Ozana river has run dry is calculated at 139 days (from august until december 1986).
