LAND DEGRADATION AND SOIL CONSERVATION WITHIN THE SIMILA CATCHMENT –TUTOVA ROLLING HILLS

Key words: land degradation, soil erosion, gulling, soil conservation

Abstract. The Simila catchment is located in the Tutova Rolling Hills, Southern Moldavian Plateau, and covers 252.83 km². The sandy - clayey Miocene-Pliocene layers have been modeled by the local geomorphological factors as a series of parallel prolonged hills which typify the entire area. The improper human activity, mainly deforestation, up and down hill farming and inadequate road network resulted in significant land degradation through the development of sheet erosion, gulling and less through landslides.

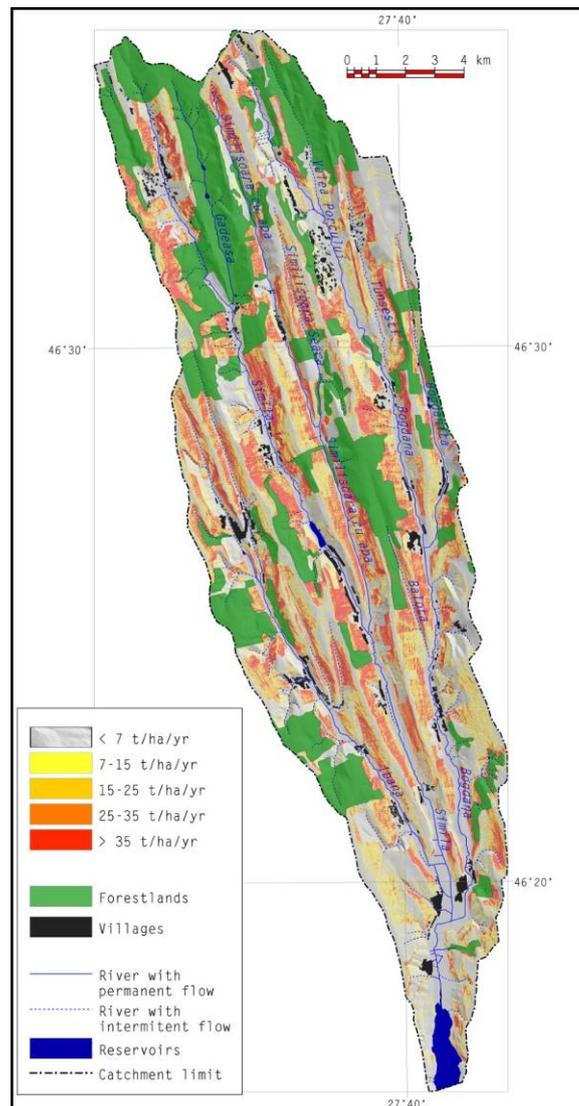
Fig. 1 – Soil losses map (according to the Moțoc method)

Using the Moțoc method, we have created a map of the average annual soil losses that were caused by sheet erosion throughout the entire basin (Fig. 1). Accordingly, on 63.5% of the catchment's area the average erosion value is under $7 \text{ t ha}^{-1}\text{yr}^{-1}$, under the admissible value of $6-8 \text{ t ha}^{-1}\text{yr}^{-1}$, which represents the natural soil regeneration ability. In contrast, the tolerable erosion threshold is exceeded on 36.5% of the area, thus: $7-15 \text{ t ha}^{-1}\text{yr}^{-1}$ on 11% of the catchment's area, $15-25 \text{ t ha}^{-1}\text{yr}^{-1}$ on 8.2%, $25-35 \text{ t ha}^{-1}\text{yr}^{-1}$ on 5.8% and over $35 \text{ t ha}^{-1}\text{yr}^{-1}$ on 11.6%.

Throughout the entire basin, the specific average value is of $12.02 \text{ t ha}^{-1}\text{yr}^{-1}$ adding to over 276500 t yr^{-1} . At the level of different landforms, higher values are registered on the cuesta fronts ($17.3 \text{ t ha}^{-1}\text{yr}^{-1}$) and on the highly degraded backslopes ($14.8 \text{ t ha}^{-1}\text{yr}^{-1}$). Among the soil types, high values, above average, characterize the erodosols ($28.9 \text{ t ha}^{-1}\text{yr}^{-1}$), regosols ($21.6 \text{ t ha}^{-1}\text{yr}^{-1}$) and chernozems ($14.3 \text{ t ha}^{-1}\text{yr}^{-1}$), used more intensely as arable lands. The arable lands are the most affected, with an average of $19.1 \text{ t ha}^{-1}\text{yr}^{-1}$, which represents over 83.6% of the total losses (Tab. 1)

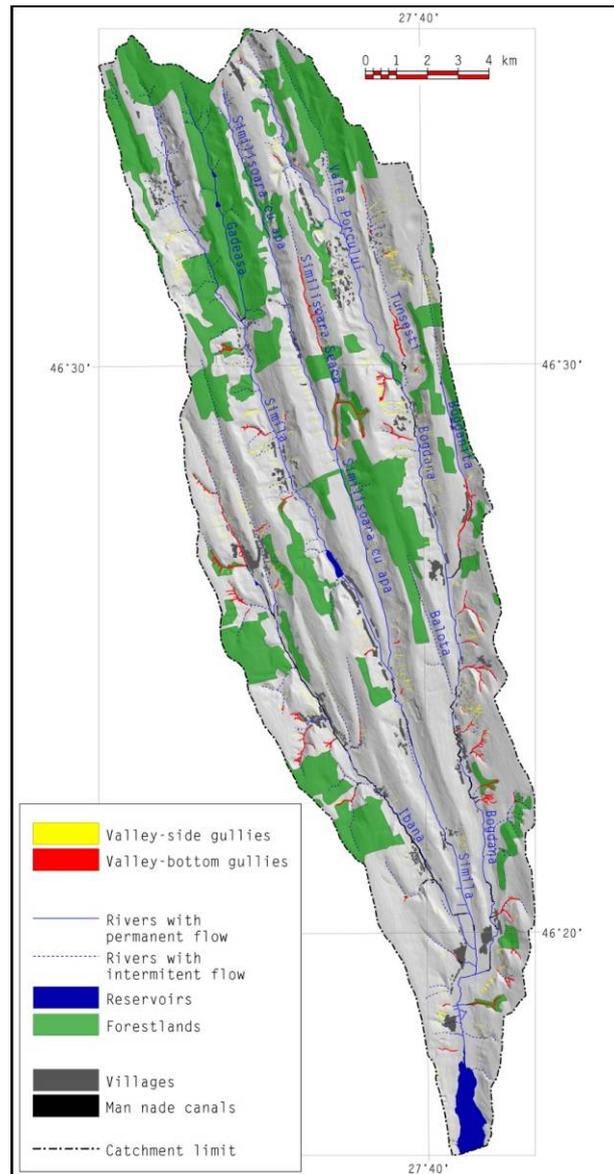
Fig. 2 – Gullies distribution map within the Simila catchment

Gullying is the second geomorphological process with a major role in the land degradation within this basin. Using a series of data taken from aerial photos, topographic maps and field elevations, we have identified 1027 gullies, 861 of them being valley-side gullies and 99 valley-bottom gullies (Fig. 2). Also, 67 manmade channels were identified.

Relative to the total area of the catchment, the highest proportion is covered by the valley-side gullies (0.28%), followed closely by valley-bottom gullies (Tab. 2). This is due to the fact that valley-side gullies have a smaller average area, of 818m², compared to the 6471m² average area of the valley-bottom gullies.

Usually, the highest gully density is found in the middle and lower sectors on mostly sandy lithology. However, the decisive factor in the initiation and development of gullies in the Simila catchment is the anthropic one, especially through the inappropriate land use.

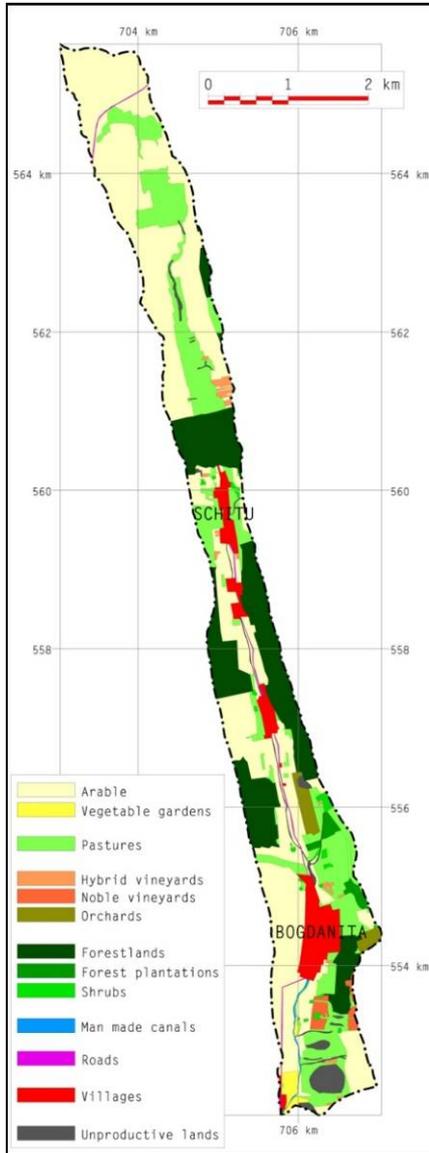
Fig. 3 – Current land use map within the Bogdănița catchment

2.2.1. Present land use pattern. According to the current land use map, within the Bogdănița catchment, of the entire area about 50% is used as arable (47.87%), 607.8 ha, respectively (Fig. 3). Actual arable land represents 597.9 ha of this area and 9.9 ha are represented by vegetable gardens. The actual arable land covers the right slope, eastern exposition backslope and also the superior third of the basin, where a structural-lithological plateau with low declivity is contoured, favorable to agriculture.

Vineyards appear mostly near the Bogdănița and Schitu villages and cover an area of 21.2 ha, 1.6% of the basin's area. The varieties grown are both hybrid (10.1 ha) and noble (11.1 ha). Orchards appear on the left slope, cuesta front, which is not favorable to use as arable, along the Bogdănița village and downstream of the Schitu village. Currently, the whole area covered by orchards (17.7 ha, 1.4% of the total area) is abandoned.

A significant area is covered by pastures (255.1 ha, 20.1%) mostly on the highly degraded lands. Forestlands dominate the middle third of the basin, on the

Of the total area of the catchment, only 232.6 ha (18.31%) are covered by forests. Near the Bogdănița village, on the cuesta front left slope, between the forestlands tree screens, shrubs and briars grow.

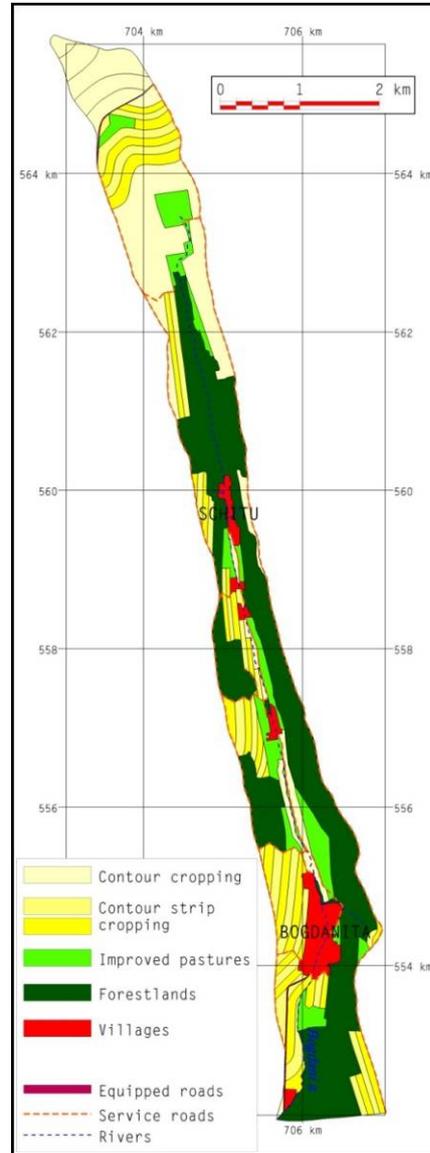
Fig. 4 – Map of the conservation practice within the Bogdănița catchment

2.2.2. *Soil conservation pattern within the Bogdănița catchment.* Starting from the current land use pattern, using topographic maps (1:5,000 scale), aerial photos from the year 2005 and field data, a soil conservation plan was drafted, with the purpose of reducing annual soil losses on the slopes and increasing agricultural production (Fig. 4).

The lands degraded through gully erosion and mass movements must be covered by forestlands. Where afforestation doesn't ensure good bank stabilization, slope stabilization works are required, or stabilizing with gabions placed longitudinally in critical spots (Hurjui et. al., 2008).

Forestlands must keep their purpose, and their area must increase to 507.78 ha (40% of the entire area of the basin) at the expense of areas with unproductive land, shrubberies or degraded pastures (Tab. 3).

a. Executing only *contour cropping* on the low declivity lands of the structural-lithological plateaus, interfluvial hilltops and at the base of the slopes, on glacises. Of the entire 1269.67 ha area, 254.94 ha have a declivity value lower than 5%, which recommends them for agricultural use.

b. Introducing the anti-erosion system of *contour strip cropping* on lands with declivity between 5% and 12%. The contour strip cropping system is suitable for use on the right slope on approximately 320.28 ha.

Havreliuc (1977) reached the conclusion that the optimal strip length is about 2000-2200 m. Therefore, in this case, a strip width between 59 m and 150 m resulted, depending on slope declivity and soil type. However, the best recommendation would be the combination between the strip-cropping system and a network of wind-breaks, each of them 12m in width.
