PESD, VOL. 8, no. 1, 2014

**CLIMATIC AND HYDROLOGICAL HAZARDS IN JUNE 26-27,
2010 IN THE UPPER BASIN OF TROTUȘ. CASE STUDY:
BETWEEN THE PROPOSED PREPARATION AND THE EFFECTS
AT AGĂȘ (COUNTY OF BACĂU)**

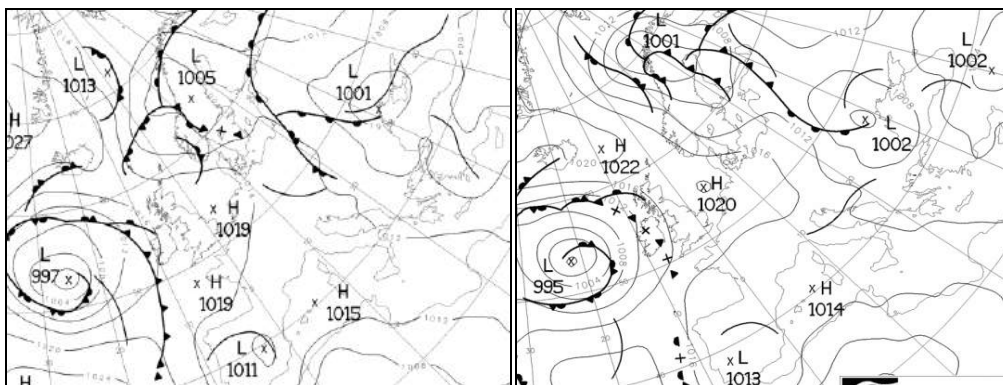
Fig. 1. The frontal ground analysis in June 25, 2010 UTC, h12.00 (source: www.wetter3.de).

Fig. 2. The frontal ground analysis in June 26, 2010 UTC h6.00 (source: www.wetter3.de)

At ground level in 25-26 June, 2010 UTC, the synoptic situation is the one on the synoptic map presented in pictures 1, 2. Romania was under a low pressure area which lies like a belt, from the South to the north-Eastern side of the continent with the main centers of low pressure disposed, one in the Northern side of the Black Sea, the other in the Scandinavian Peninsula.

Abundant rainfall during the day of June 25, 2010 had front causes (picture 1) accompanied by the instability level during the afternoon (picture 5).

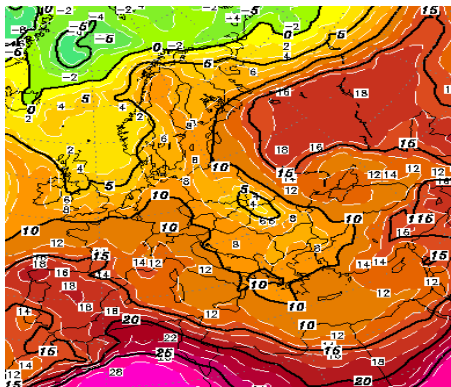
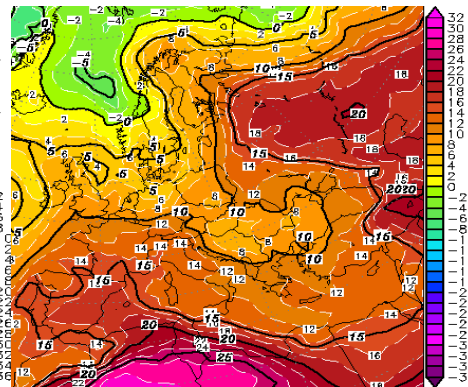
In the temperature land al the level 850 h Pa, our country is under the influence of an air mass of polar maritime origin, the whole territory of Moldavia being situated between 8-10° (fig 3,4).

Fig. 3. The surface-level air isobaric temperature of 850 hPa on June 25, 2010, h00.00 UTC (source: <http://www.wetter3.de/Archiv/>)

Fig. 4. The surface-level air isobaric temperature of 850 hPa on June 26, 2010, h6.00 UTC (source: <http://www.wetter3.de/Archiv/>)

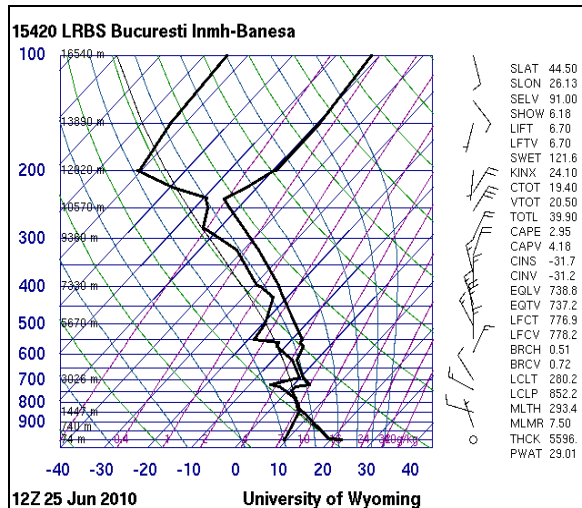
Fig. 5 - Diagram Skew-T from June 25,2010 h 12 UTC (sursa:<http://weather.uwyo.edu/upperair/europe.html>)

The diagram (fig.5) where is the vertical profile of the atmosphere and assesses the stability of the atmosphere in Bucharest on June 25, 2010 h 12.00 UTC, indicates: K-INDEX= 24 (chances to develop clouds Cb); CAPE= 295 J/kg; Total Index = 40 (probability to appear clouds Cb).

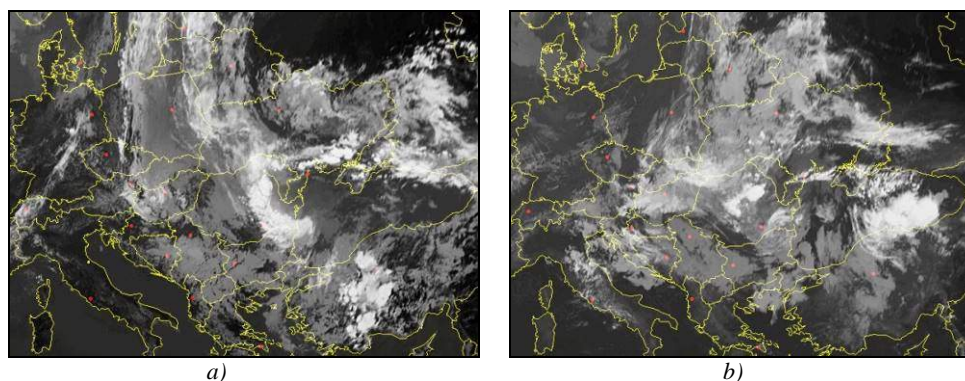
In the first part of the day of June 26, 2010 were met conditions by the occurrence of precipitation due to the hot thermal convection. All these happened as in the pictures from the satellite (fig. 6).

Fig. 6 a,b From satellite, in infrared, on June 25, 2010 h 12.00 UTC (a) and June 26, 2010 h 7.00 UTC (b) (source: <http://www.sat24.com/history.aspx>)

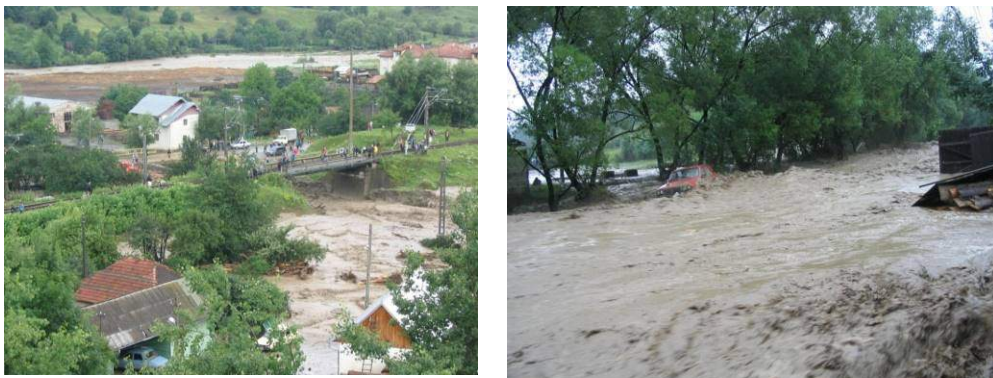
- Important precipitations (over 130 l/mp) beside the water from the land, in spring, which comes from the snow
- The damage of the embankments because of too much water and the long period (over 20 days when appeared infiltrations – fig. 7. a, b)

a) b)
Fig. 7. Effects of hazard event in Agăș

- massive deforestation and unsuited agrotechnical works which help the erosion and lead to a bigger flow and important quantities of silt (fig. 7. a, b)
- The gullies and ditches are not enough, and the ones that exist in the rural area are not well used and kept (fig. 7. b)
- The clogging and the bad keeping of the gullies and ditches, which are not enough and properly for floods (fig. 8. a, b)
- Unauthorized buildings that appear in the flood areas

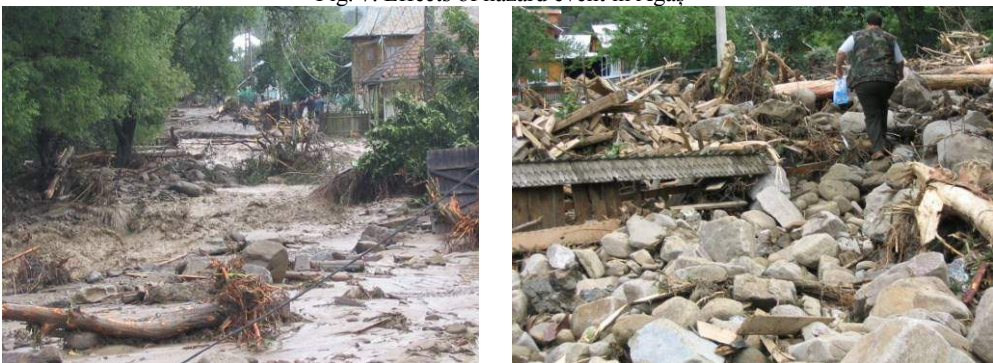
a) b)
Fig. 8. Effects of hazard event in Agăș

- Poverty, unauthorized buildings, bad projects, low quality materials and the lack of administrative rules for buildings (fig. 8. a, b)
- Overloaded transports on bridges and waste products which ruin the channels, already too few. Illegal deposits of sawdust from the major basins of Trotus and affluent are big pollutants
 - The works around the bridges are not made according the legal notices
 - The lack of enough materials and means of the local administration in case of floods
