Fast floods on the tributaries of Trotuș river, in the context of current climate change

Abstract: The paper presents an analysis of the flood formation module in the Trotuș river basin and especially on its tributaries. A special situation was recorded in 2004 when the floods formed on the tributaries presented very high flows, but which did not substantially influence the flow of the main course. The floods produced on the river / stream / torrent type tributaries (example: Asău, Agăș, Goioasa, Iedera) presented flows that exceeded the accepted calculation probabilities. The floods produced were both the effect of torrential rainfall and the configuration of the lower sectors of the riverbeds. The floods produced in 2004 on a series of tributaries of the Trotuș River presented maximum flows that exceeded the calculation probabilities of 0.1% (Agăș - 183 m³/s, Beheghet - 50.70 m³/s, Goioasa - 67.10 m³/s, Iedera - 127 m³/s). The sudden change of the slope on the lower course of the tributaries determined the deposition of a large volume of alluvium, a situation that reduced the flow section and even blocked it. The result of the corroboration of natural and anthropogenic situation

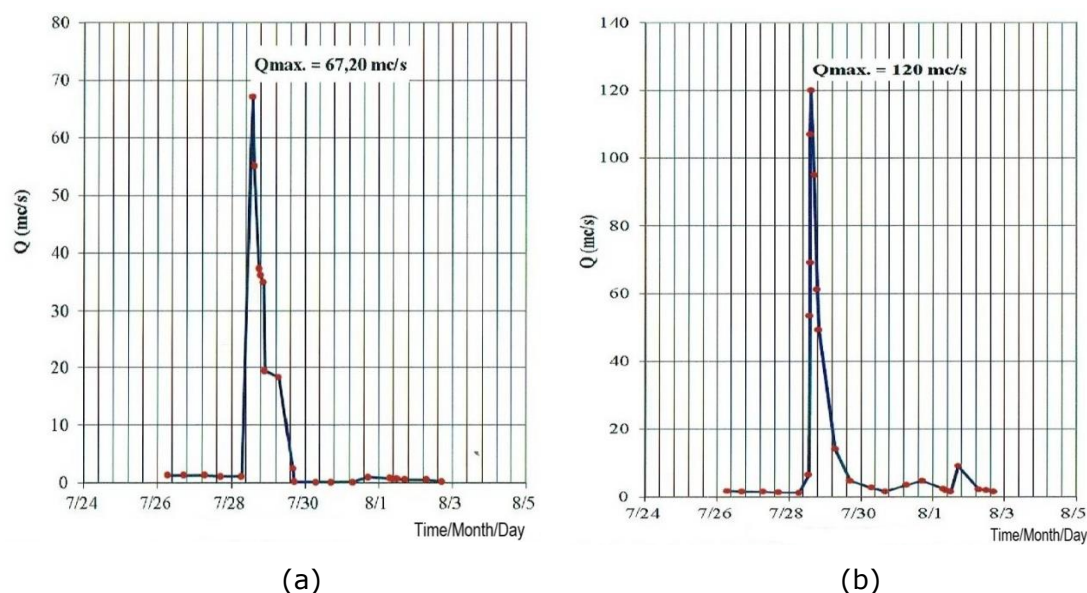
Figure 2. The flood hydrograph from the period 26.07 - 03.08.2004: a - SH Ciobanus; b – SH Asau (Avram, 2020).

From the analysis of the data in table 1, it follows that on the upper course of the Trotuș River (upstream of Goioasa) and in the hydrographic basins of the tributaries Valea Rece, Sulta, Slănic, Oituz, Tazlău, but also on the lower course of the Trotuș River, there were no maximum flows causing significant flooding. The biggest floods occurred on the Trotuș River on the Goioasa-Târgu Ocna on the large tributaries Ciobănuș and Asău (Figure 2 and Figure 3) and especially on several small tributaries from the Goioasa area. The flood hydrograph shows the fast way of flood formation and evolution.

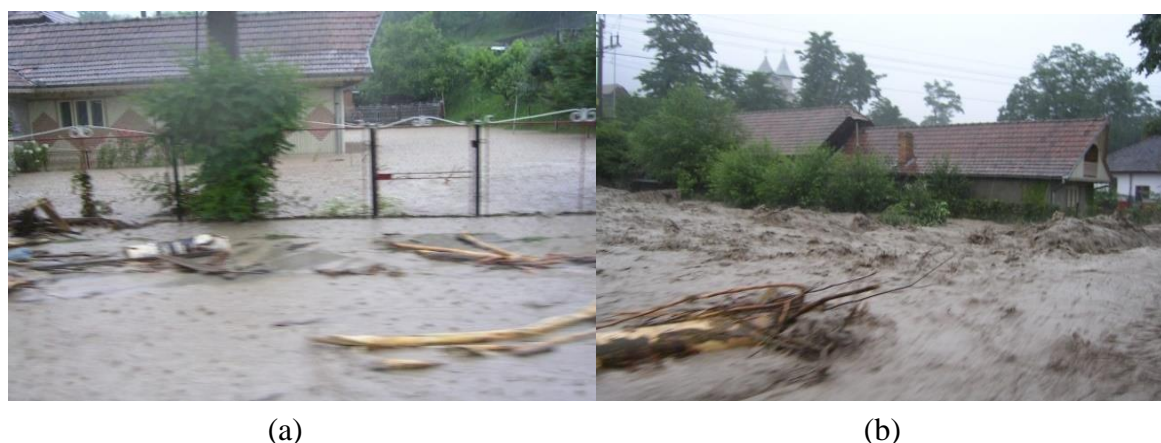
Figure 4. The effect of the 2004 flood in Agăș commune, Agăș river: a - flooded dwellings; b - important solid transport on the traffic routes in the locality (WBA Siret, 2004).

Studies carried out in the last 20 years have indicated an increase in the degree of torrential rainfall in the Trotuș river basin (Avram, 2020; Romanescu and Nistor, 2011; Manolache, 2018; Avram et al., 2018). The floods of 2004 in Trotuș River basin caused the death of 3 people and approximately 762 homes and households were destroyed by the floods (Table 3, Figure 4). Also, they were flooded approx. 280 ha of agricultural land, 26 km of roads, 9 economic objectives and 309 bridges. In 2004, about 13.4 km of hydrotechnical works carried out on the Trotuș River were partially or totally destroyed (Figure 4 and Figure 5).

Alluvial deposits in the riverbed were large, with thicknesses of up to 1.50 - 2.0 m, which partially blocked the flow on certain sectors of the main watercourse, but also on tributaries. Alluvial deposits produced changes in the normal flow regime, with influences

on the stability of banks and bank defences when crossing urban areas (Figure 4 and Figure 5).

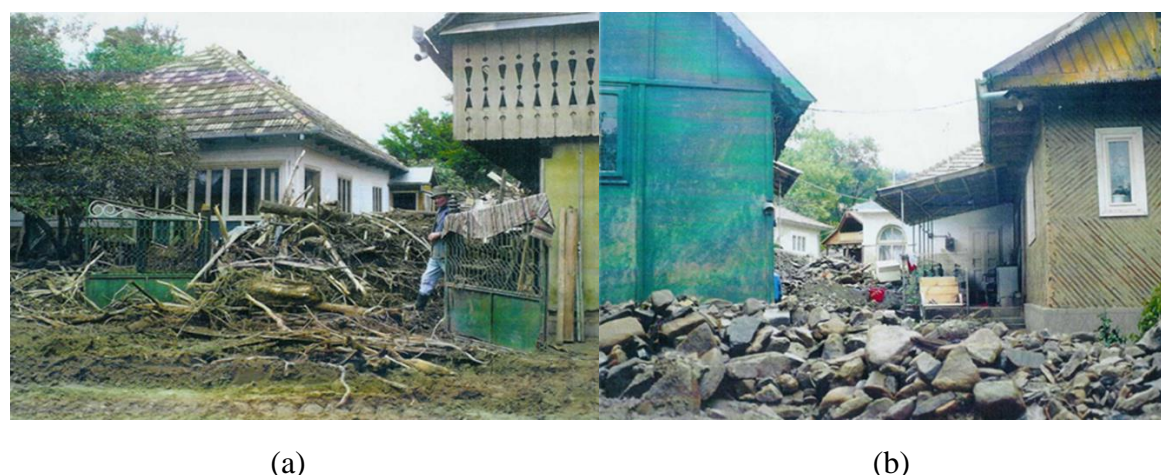
Figure 5. The effect of the 2004 flood in the Agăș area through deposits in the riparian area: a - forest material; b - mooring with variable dimensions (WBA Siret, 2004).

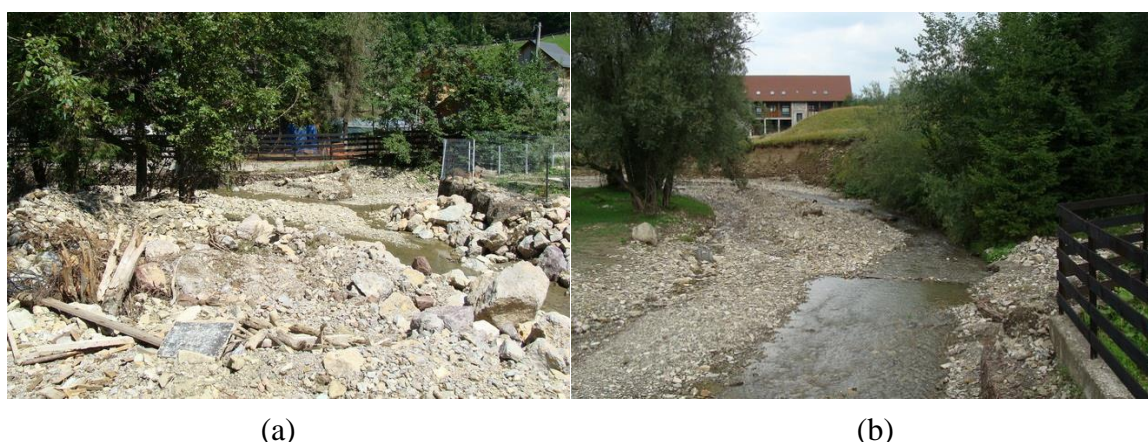
Figure 7 Alluvium transport on the Voroneț River during the 2016 flood: a – large stone and gravel on the upper course; b – gravel on the middle course (Luca et al., 2017).

In the period 2014 - 2020, several researches were carried out in small hydrographic basins regarding the effect of floods. Thus, the research carried out in 2016 in the hydrographic basin of the Voroneț River (Luca et al., 2017), a tributary of the Moldova River, highlighted a series of flood characteristics similar to those produced on the Agăș River in 2004 (Avram, 2020). The June 2016 flood on the Voroneț River presented a large volume of alluvium consisting of large stones, gravel and forest material (Figure 7). The alluvium mixture was transported by the flow with a calculation probability of 1% and accentuated the hydrodynamic erosion of the bed and riparian area (Luca et al., 2019).
