THE IMPACT OF LANDSLIDES ON THE DN15 NATIONAL ROAD IN THE AREA OF THE IZVORU MUNTELUI – BICAZ RESERVOIR

Claudiu Gaman¹

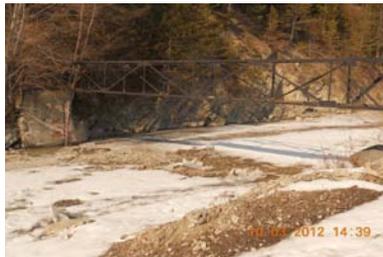
In the same period it was noticed that on the road from the dam to Poiana Largu all the brooks were depleted although at the end of the second decade of February 2012 were registered heavy snows (Fig. 14). Immediately downstream Vârlan brook were conducted some flood control works for a small torrent that had affected the road platform (Fig. 15).

Fig. 14. Poiana Largului hydrometric station on Bolătău brook
