## STUDIES REGARDING THE SAFETY IN OPERATION OF EZER RESERVOIR

**Abstract.** The dam of the non-permanent reservoir Ezer, located on Jijia river is an earth dam with a maximum height of 6.18 m, which provides a global retention to the canopy of 10.330 million cubic meters. The dam founded on weak, muddy soils suffered in the years 1989 and 1992 downstream slope failures of the fillings. It was found that hydrostatic levels were high in the piezometric wells and that consolidation of the foundation soil was reduced. This paper presents a brief history of the dam and aspects regarding the behaviour monitoring of Ezer non-permanent reservoir during the years 2000-2012.

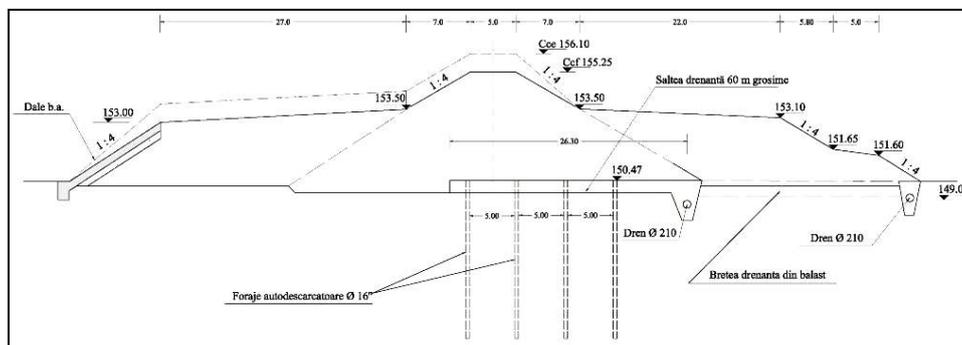
In order to descend the seepage curve through the dam a draining ballast mattress was placed on a 0.6 m width and 471 m long geotextile layer at the foundation soil. The consolidation of the foundation soil was accelerated by a system of 310 draining wells, arranged in 4 rows in the middle of the meadow, where muddy clay layer is thicker than 20 m. The 16" nominal diameter wells filled with ballast have an 8.0 m depth. The top of the wells is placed, on a 0.6 m depth, in contact with the draining mattress by a network of draining ditches filled with ballast.

Collecting and dripping water from the wells and the draining mattress is achieved through 2 parallel 300 mm nominal diameter culverts. Between these culverts, on the foundation soil of the downstream berm, 0.7 m width and 0.5 m high ballast straps were placed. The connection of the culvert with the draining mattress is made through a ballast prism with 0,5 m low base width, 0,5 m height and 1: 1 downstream slope thus ensuring the continuity of the draining mattress with the ballast straps drainage. (Fig. 1).

Fig. 1 – Cross section of the dam body – design phase

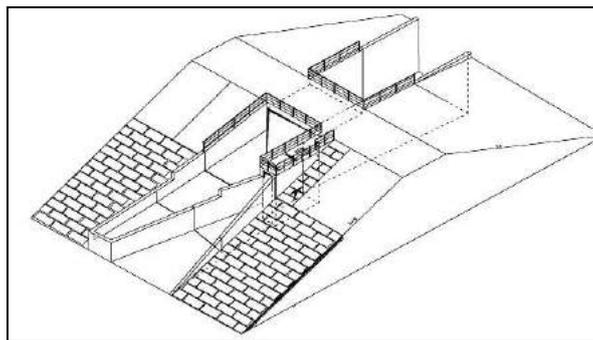
➤ Structural elements: “crocodile weir” type overflow, frontal, with 2 discharge thresholds, energy dissipator, gravel channel, connecting earth channel;

Surface outlet dimensions: total length 151 m, I<sup>st</sup> threshold discharge front length=32.0 m, II<sup>nd</sup> threshold discharge front length=8.0 m (Fig. 2).

Fig. 2 – Axonometric view of the surface outlet

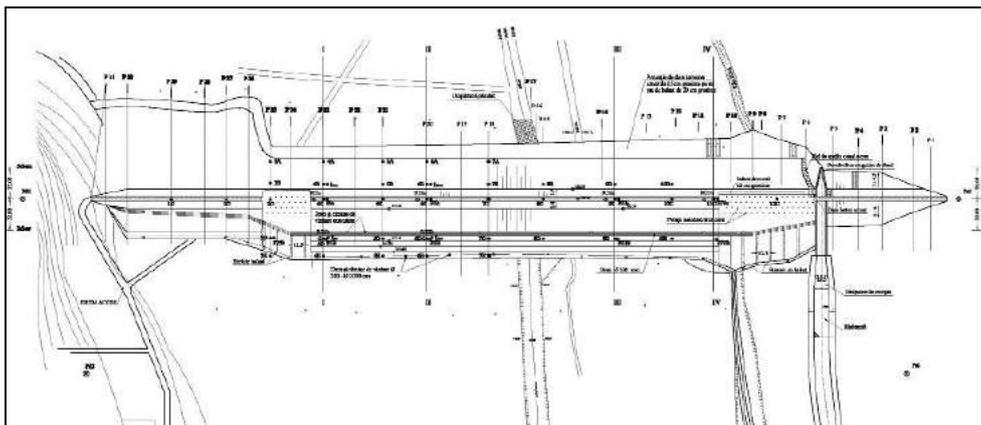
The measuring installations of the dam and its foundation are mainly distributed in 4 major characteristic sections, marked with I-I.....IV– IV.

- For tracking the evolution of vertical deformations are used:
  - 40 vertical axis landmarks on the dam, of which 14 on the canopy and 26 on the 2 berms (upstream and downstream slope);
  - 6 fixed landmarks;
  - 4 landmarks on the operation tower;
  - 4 inclinometer columns;
- For tracking the evolution of body dam seepage, 8 piezometric wells are used;
  - To measure the interstitial pressures in the foundation soil 14 piezometers are used. They are placed in 8 wells, each of them containing 1 or 3 thin tubes (Fig. 3).

Fig. 3 – Dam body plan view with the location of the measuring installations

The measuring installations were distributed on the dam mainly in 4 characteristic sections as noted I-I. ....IV-IV. The piezometric wells marked with Pic1, PIIc1, PIIIc1, PIVc1 - c4, located on the dam canopy and PIb1, PIIb1, PIVb1 located on the downstream berm, were designed to capture the seepage regime through the dam body. Piezometric wells of different depths Pic2 – 3, PIb2 - 3 PIIc2 - c3, PII b2 - 3 PIIIc2 - c3, PIIIb2 - b3, PIVc2-3 enter in the foundation soil and are designed to dissipate interstitial pressures in the foundations' muddy soil.
