THE IMPACT OF MINING INDUSTRY ON THE LANDSCAPE OF MARAMUREȘ COUNTY

Abstract. Having been mentioned for centuries, the mining industry and its activities have been at the same time an important means of economical development in the region and a major source of pollution for the environment. Moreover, it has altered the features of the natural habitat in Maramureș. This study aims to highlight the impact that mining industry has on the environment of the county and to present the main aesthetical consequences of carrying out such activities.

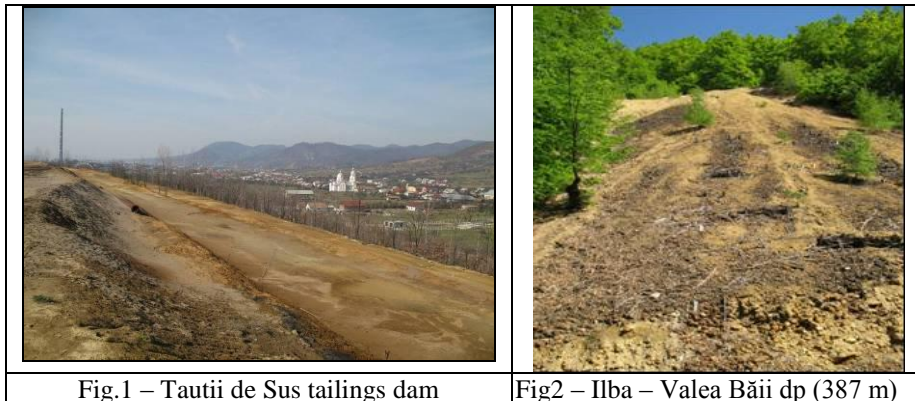
In Maramures there are over 500 mine spoil dumps, out of which only 300 dumps that deposit 4 mil tones are registered in the documents of mine operators. We consider that these dumps present mechanical instability due to the wide angles of the huge piles, due to ditches, spoil washouts, as well as due to the downward

migration of pollutants (heavy metals) caused by exfiltration and alkalisation (Fig 2).

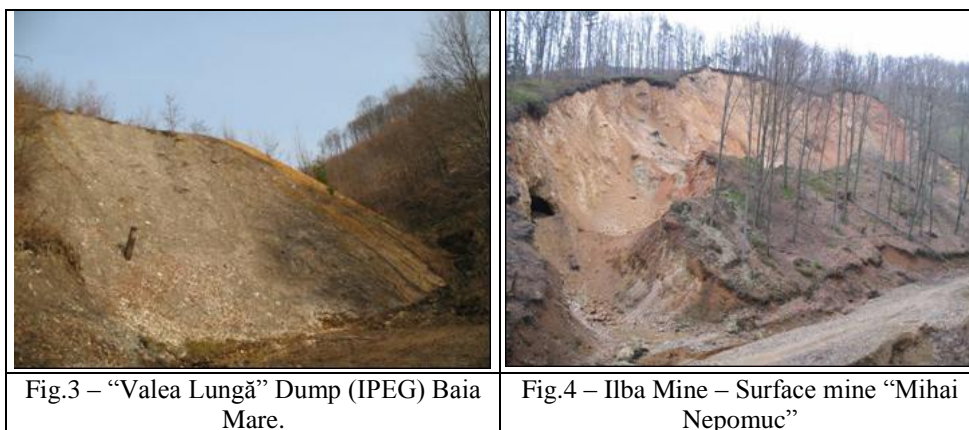
Fig.3 – “Valea Lungă” Dump (IPEG) Baia Mare.

On the other hand, the deflation phenomena that affect the flotation waste on the surface of the dump have major negative impact on the surrounding places such as Bozânta, Săsar, Tăuţii de Sus, Baia Mare and Borşa (Fig. 3).

Surface minings at Hanău –Ilba, Mihai Nepomuc – Ilba, 11 Iunie – Nistru, Baia Sprie, Şuior, Măgura – Borşa, Răzoare, are mainly responsible for the appearance and evolution of soil erosion, acidification and migration of harmful elements into the surface receptors (Figure 4).

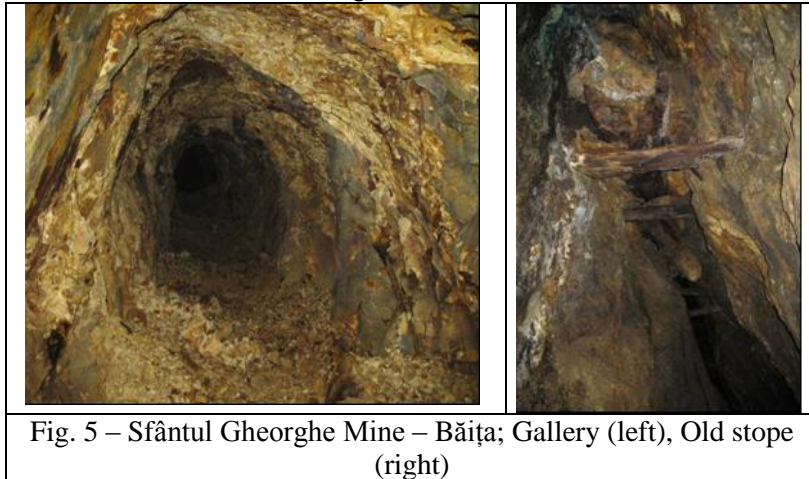
Fig. 5 – Sfântul Gheorghe Mine – Băița; Gallery (left), Old stope (right)

Underground mining – that consist of over 1000 km galleries in the mines of Ilba, Nistru, Săsar, Herja, Baia Sprie, Şuior, Cavnic, Băiuţ, Băiţa, Borşa and IPEG galleries in all Maramureş county cause underground sinkholes that - under the influence of the interior pressure led to landslide, uncontrolled mine water

accumulation as well as its acidification due to the contamination of surface and underground water with minerals (Figure 5).

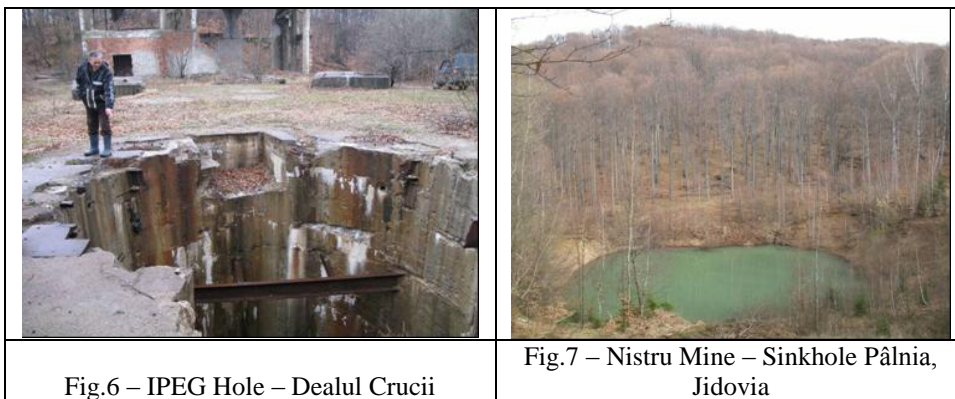
Fig.6 – IPEG Hole – Dealul Crucii

Drilling in the underground caused numerous sinkholes on the mine surfaces at: Purcăreț, Firizan, Nucuț – Ilba; Jidovia, 9 May, Lăpușna – Nistru; Borzaș, Sofia, Aurum, Valea Roșie, Dealul Crucii – Săsar Baia Mare; Herja Superior; Limpedea, Crăpătura Zorilor - Baia Sprie; Cariera Șuilor; Breiner, Petru and Pavel – Băiuț; Gura Băii – Borșa) (Fig. 6).

Through these holes pluvial water infiltrates, it acidifies due to contamination with metals in the deposits and, combined with heavy rain it creates huge amounts of water in the underground, as well as violent phenomena such as heavy floods.

Also, infiltration of surface water in the underground can occur through karsts and crevices formed above some mines where the mining activities are run near the surface (Jidovia – Nistru, Băiţa, Valea Roşie – Baia Mare, Conci stream – Băiuţ) (Fig.7, Fig. 8, Fig. 9, Fig. 10).

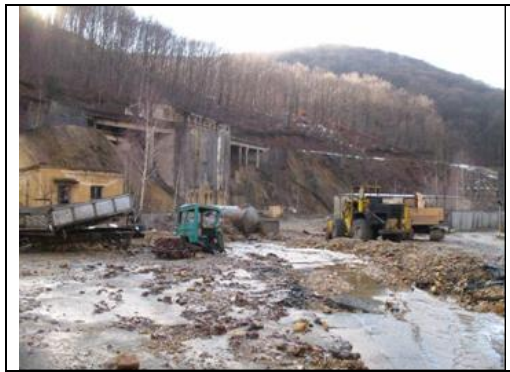
Fig.11 Ilba mine – mining site

Huge surfaces (hundreds of hectares) on which abandoned constructions and equipment connected to mining industry were left derelict (at present most of them being devastated) will represent a major environmental problem due to the corrosive process they undergo.

Such dangerous factors are: buildings, flotation plants, storehouses for mining materials and concentrates, mine access roads, large quantities of scrap iron (rails,

tubes, pipes, cables, metallic structures, anchors); electric cables, electric equipment, tools and installations (trolleys, engines, mining pumps, extraction machine, loading machines, electrical engines) that were not removed because their removal was not profitable. They will be a major environmental issue for a very long time (Fig. 11).

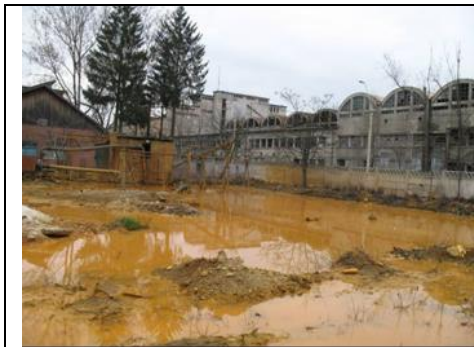
Fig.12 – Săsar mine – mine water evacuation plant

Similarly, a negative effect on the environment can be caused by evacuating mining water directly into nature or by the insufficiently purified mine waste waters in the 5 water treatment plants at Toroioaga- Borșa, Tyuzosa – Băița, Câmpurele – Nistru, Valea Colbului – Ilba and Herja – Baia Mare (Fig. 12, Fig. 13, Fig. 14, Fig. 15).
